Jewel on the Hill

Thomas Hunter Hall is the surviving wing of a larger structure designed by architect Charles “C.B.J.” Snyder. When built, it was one of a dozen hospitals, homes, orphanages and other institutions devoted to the civic good on Lenox Hill on the Upper East Side of Manhattan.

Thomas Hunter Hall is now the oldest building in Hunter's campus. Years of neglect made it necessary to erect a sidewalk bridge around the base of the structure in 2005 for the protection of pedestrians. A \$13,000,000 repair project on the building was initiated by the Dormitory Authority of the State of New York in 2007 and is now complete.

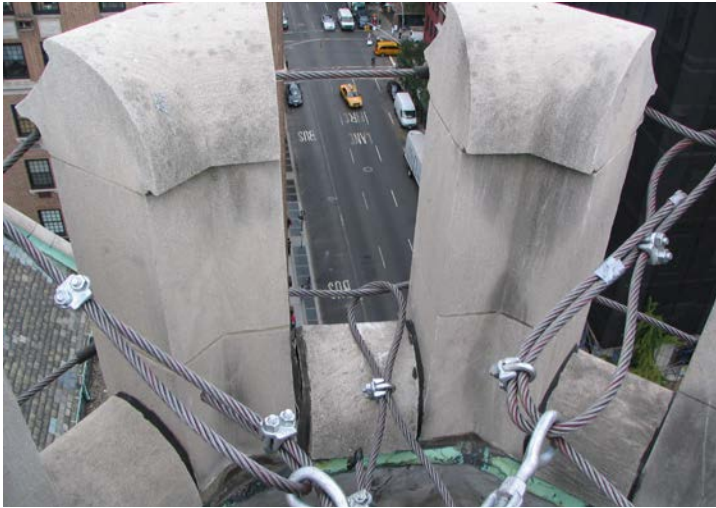
Shifting limestone units in the turrets had to first be stabilized for safety and to preserve original stone to use in reconstruction.

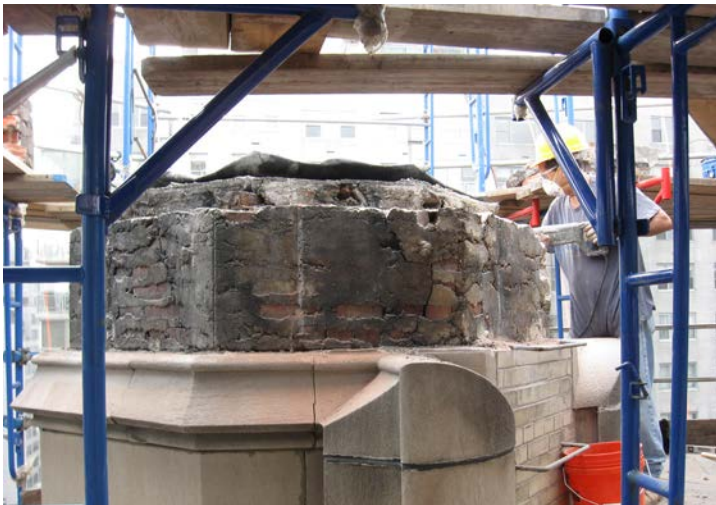
Turrets were deconstructed to prepare for reassembly with limestone units carefully numbered and stored for reinstallation after the masonry base was reconstructed.

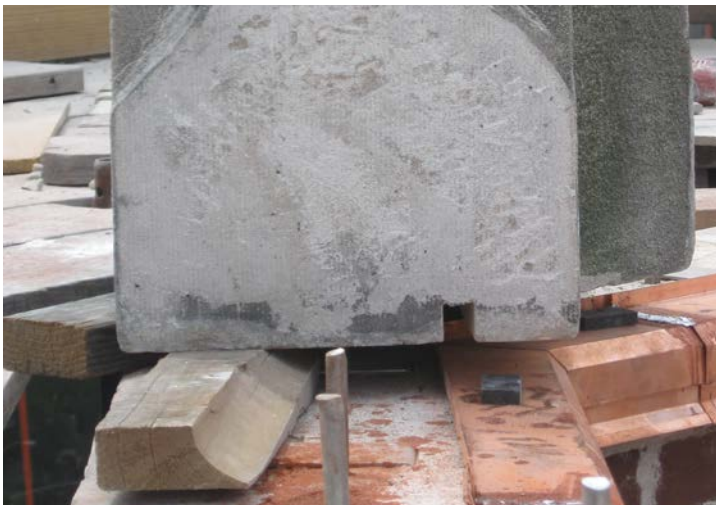
New stainless steel pins and copper flashing installed under reset original stone in turret.

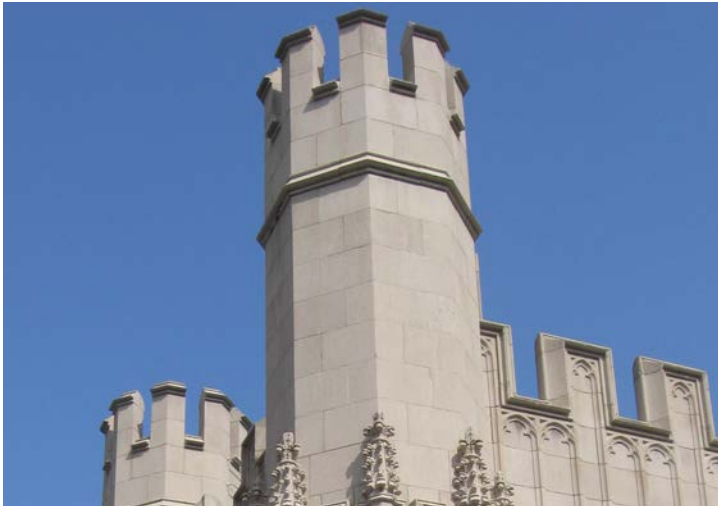
Reconstructed and cleaned turrets.

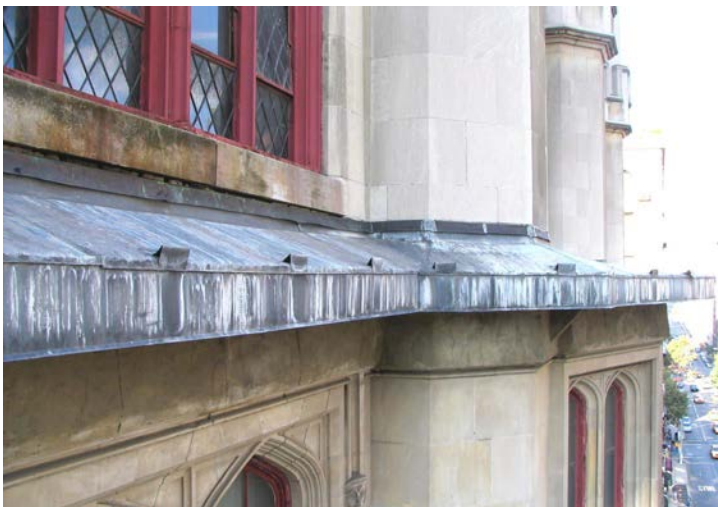
Before restoration, deteriorated metal roof and flashing over missing cornice and cracked stucco covering "scars" where original terra cotta cornice had been removed

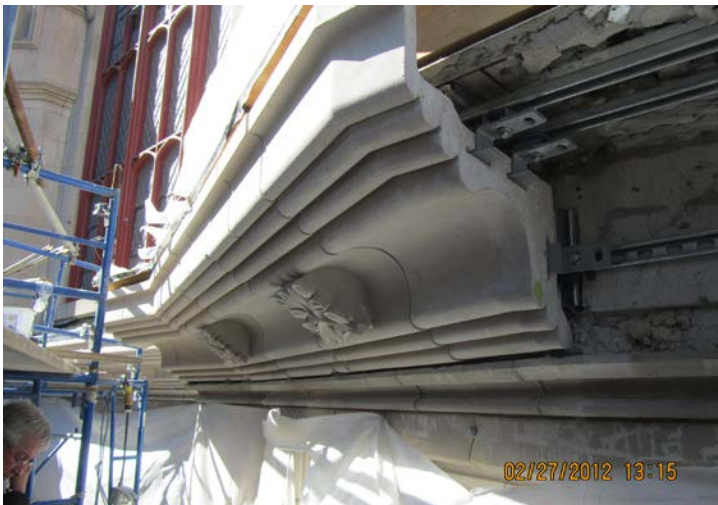
Reconstructing cornice -- underside done with glass fiber reinforced concrete. Photo research was conducted to reproduce design of original terra cotta cornice.

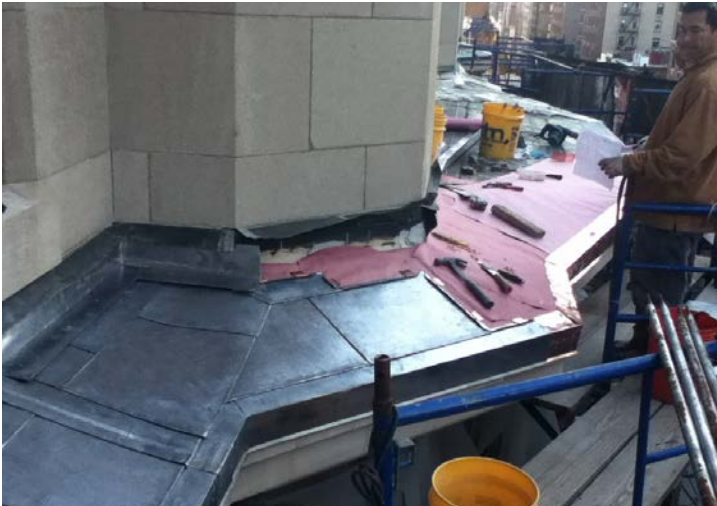
Lead coated copper roof was installed on top side of the new cornice.

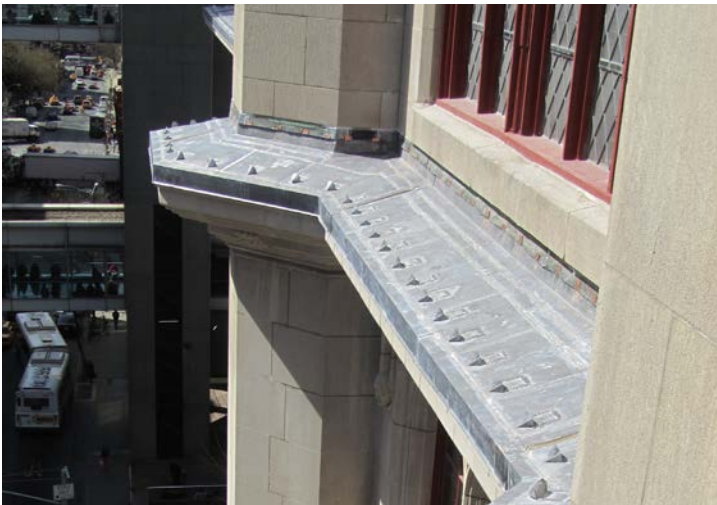
Completed roof over new cornice.

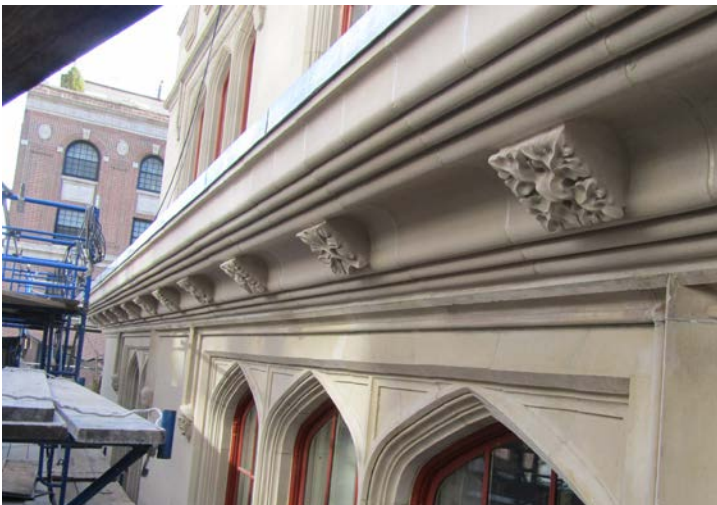
Completed cornice with GFRP replicating original terra cotta cornice details.

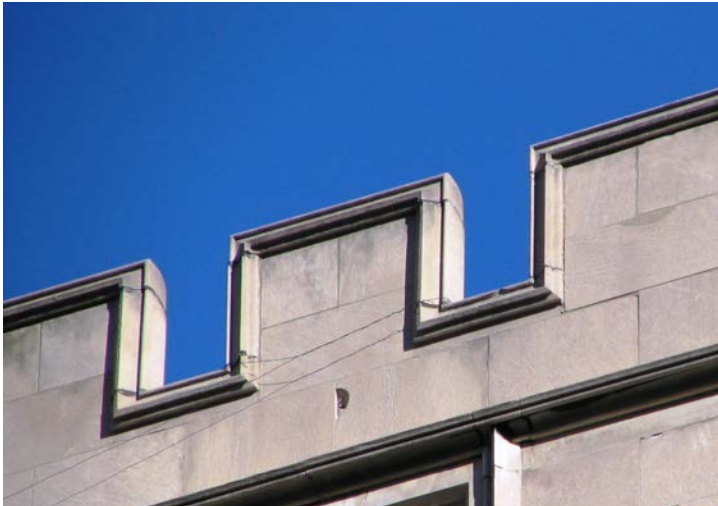
Parapets before reconstruction.

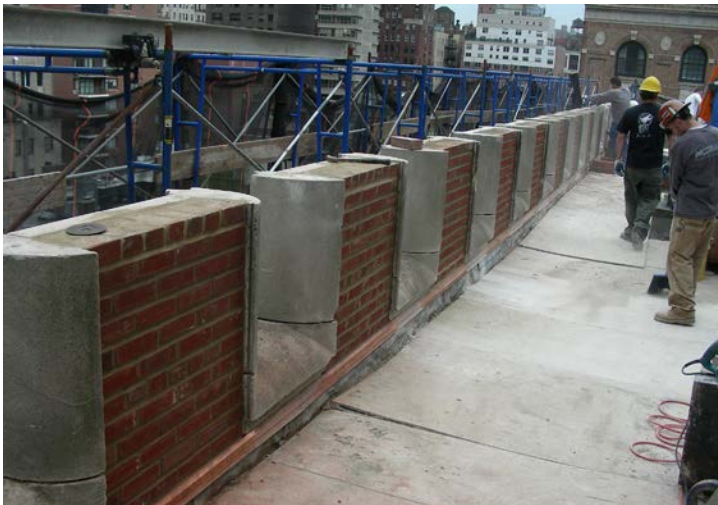
Parapets during reconstruction.

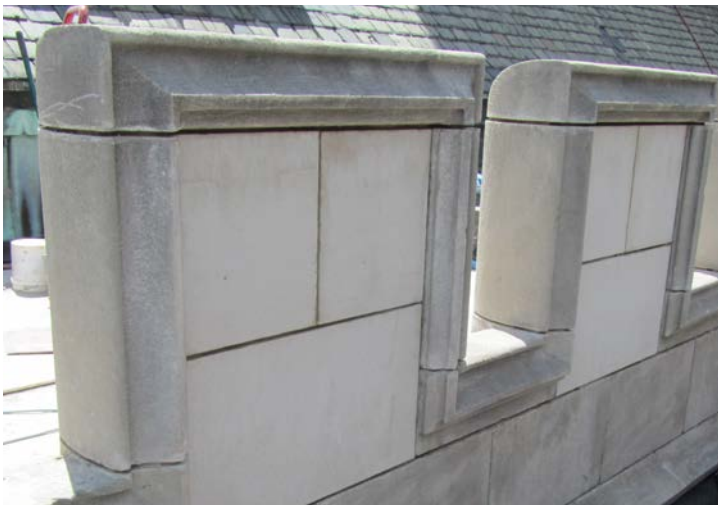
Parapets during reconstruction.

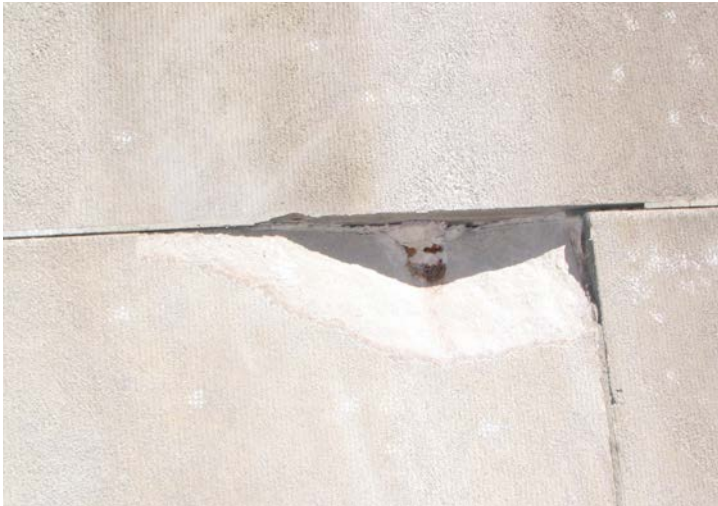
Typical existing condition: limestone deterioration at rusting iron cramp

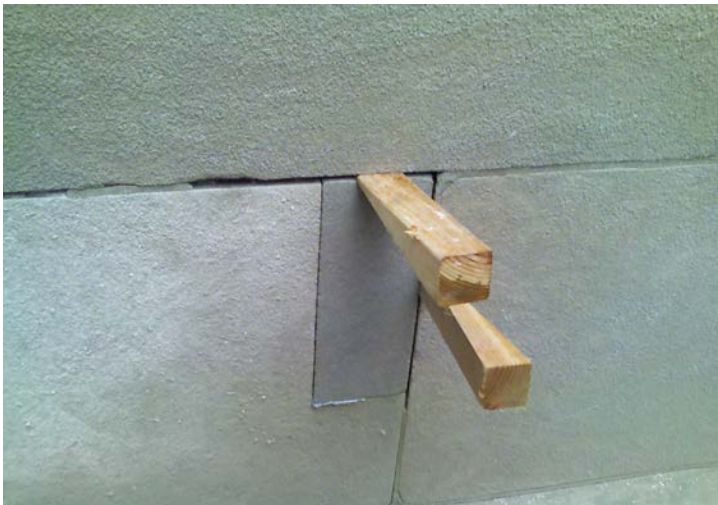
Dutchman repair to limestone. Patching was done in more ornate areas.

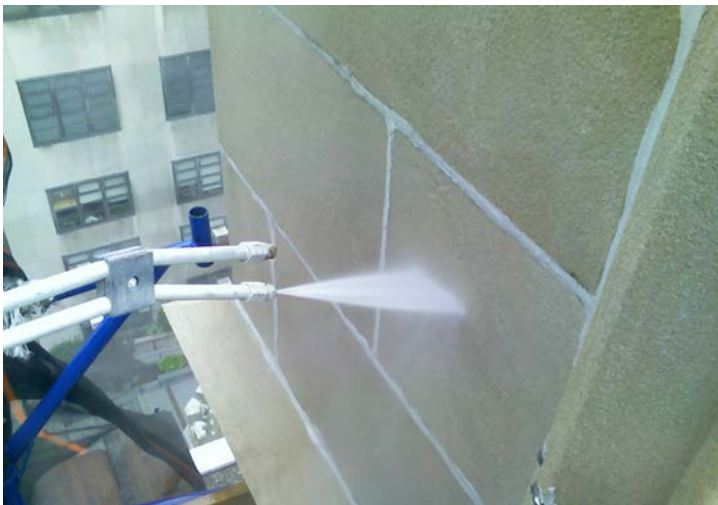
The scope of work on this restoration included a full cleaning of the building's limestone.

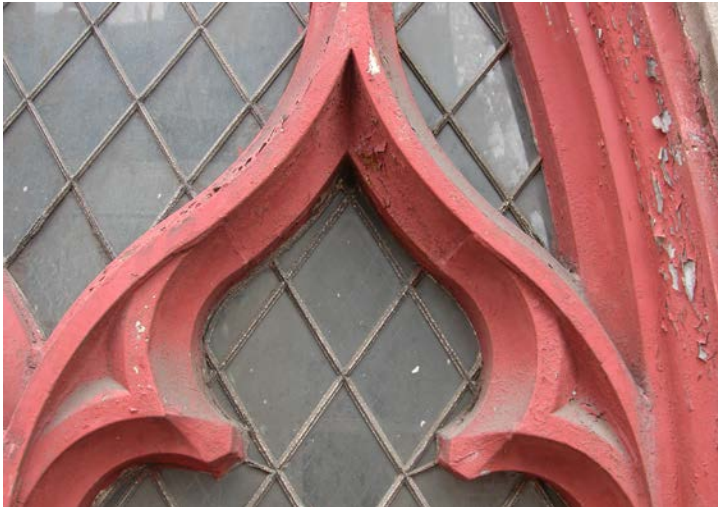
Leaded window before restoration.

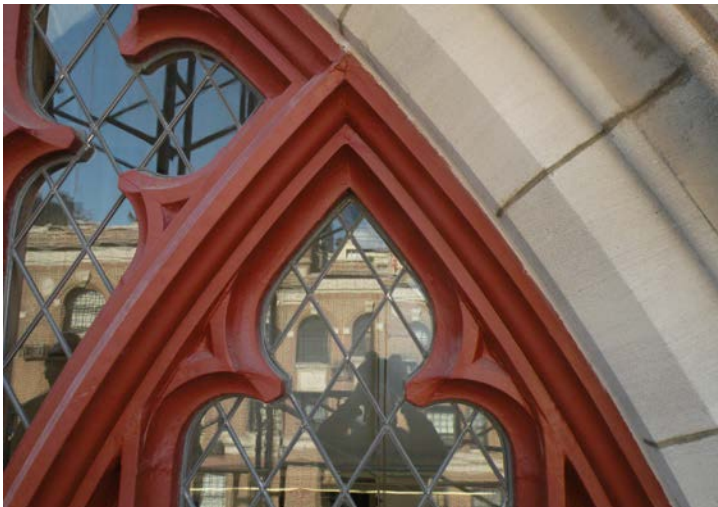
Leaded window after restoration. For the leaded glass windows, work included restoration of rusted sheet metal frames with sheet metal and epoxy patches, reglazing of zinc-leaded panels with new lead comes and new clear glass, restoration of steel pivot sash, reinstallation of re-leaded panels.

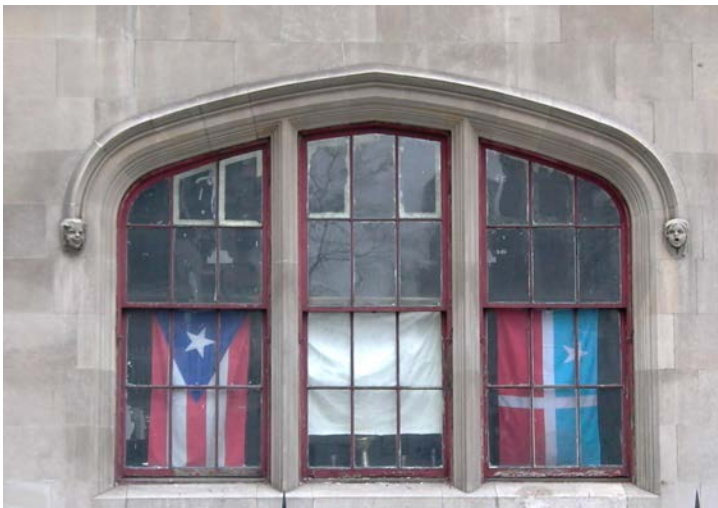
Wood window before restoration. All original wood window frames were restored by epoxy consolidation and installation of wood dutchmen, as well as the fabrication and installation of new wood sash with clear Low-E insulated glass for energy efficiency.

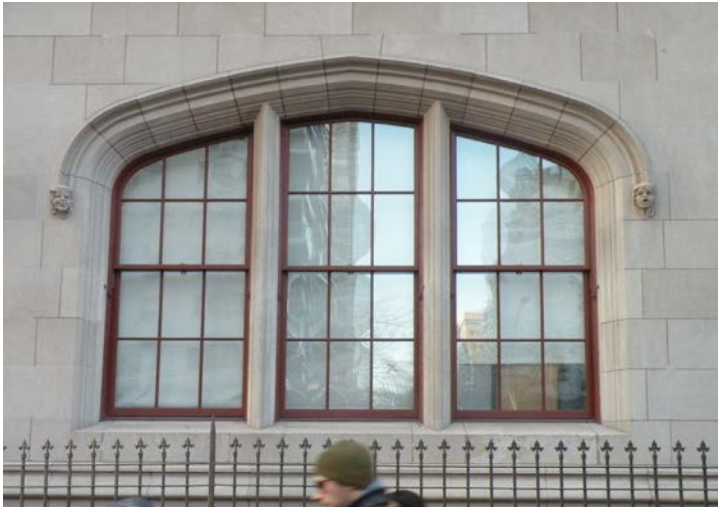
Wood window after restoration. The window restoration work encompassed thirty different window types, including arched-head double-hung wood windows, monumental leaded-glass windows set in sheet metal frames intended to imitate stone Gothic tracery, wood pivot-sash, and steel fire-rated windows.

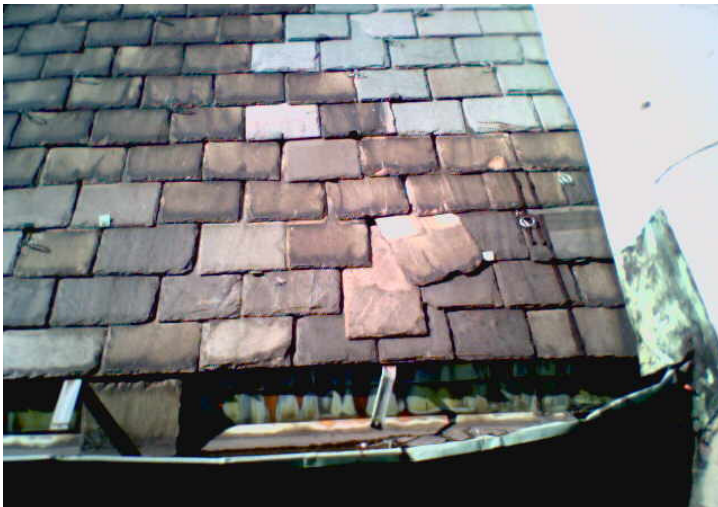
Slate roof and copper gutter before restoration.

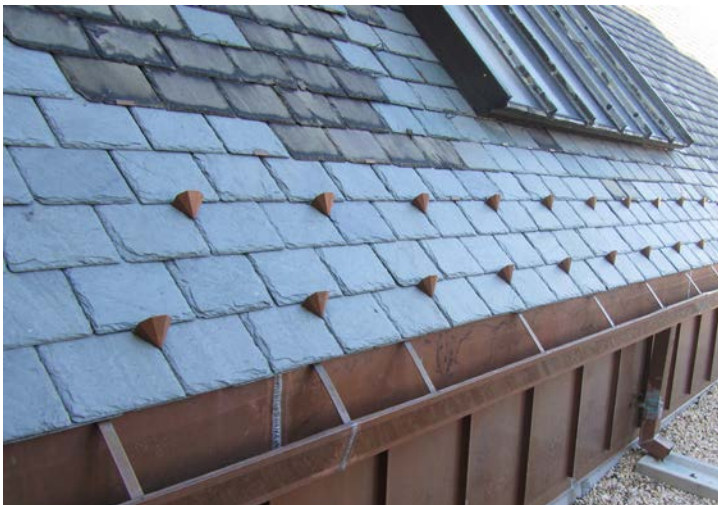
Slate roof after restoration. Original building fabric was retained where possible.

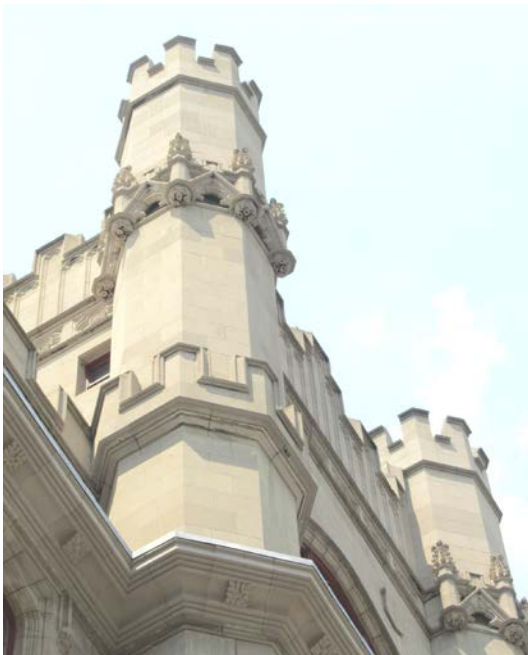
Restored turrets at Thomas Hunter Hall
