FIELD REPORT

Project:	Fire Island Lighthouse Testing Prog.	Report #:	2
Inspection Date:	June 10-June 14, 2019	Conditions:	64°F-75°F, Variable
Contractor:	Apple Restoration (Apple)		
Prepared by:	Corey Manchenton	Reviewed By:	Nancy Rankin

SUMMARY – WEEK 2

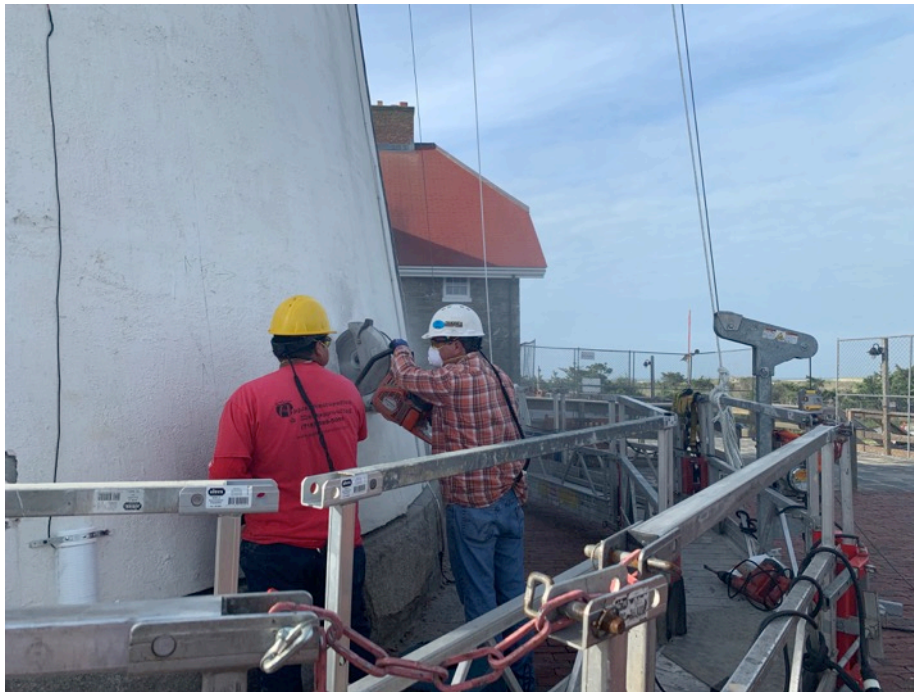
Photograph #1

Removal of concrete began, utilizing power tools and dust collection when feasible.

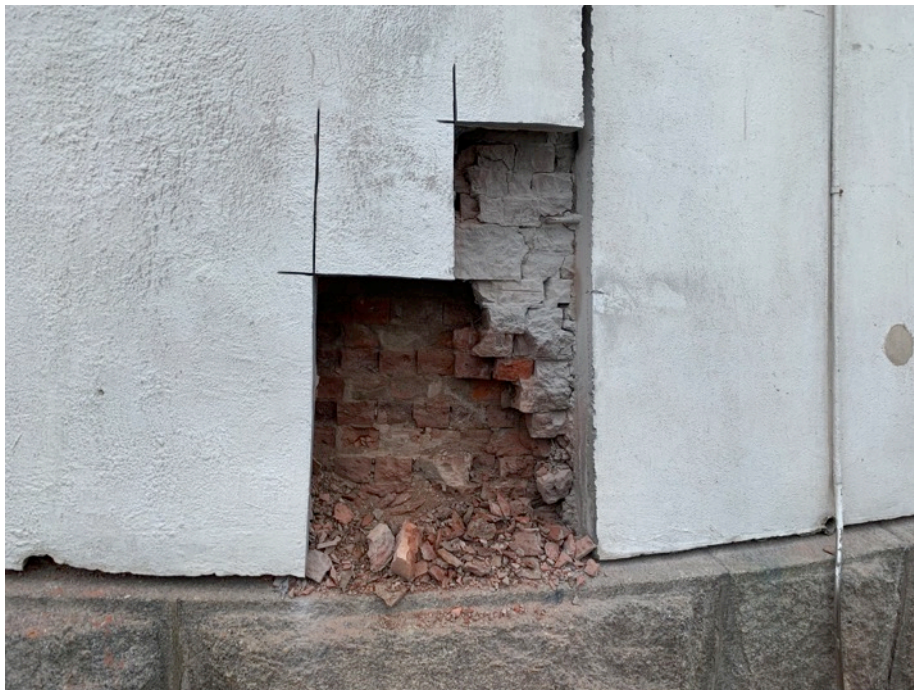
Photograph #2

- (1) The brick masonry behind the concrete shell at the top Ring 1 was damp (Photos #3-#4), while the masonry at the base of the probe was dry.
 - b) Removal of concrete revealed that the exterior wythe of the brick masonry is either directly adhered to the concrete shell and was removed still attached, or is loose, deteriorated, and/or no longer an integral part of the rest of the brick structure. (Photo #5)

- (1) The outer wythe of the system appears fully independent of the rest of the brick wall structure of the lighthouse and is only comprised of only stretchers, and if brick masonry is removed (whether due to adhesion to the removed concrete shell or otherwise) all brick masonry at the exterior wythe above the removed area has the tendency to fall out.

Removal of concrete revealed that the exterior wythe of the brick masonry is loose, deteriorated, and/or no longer integral with the brick structure directly behind. When brick masonry is removed all brick masonry at the exterior wythe above the removed area has the tendency to fall out.

- 2) **Further removal of the concrete shell will continue to be monitored, particularly in relation to the brick masonry.**

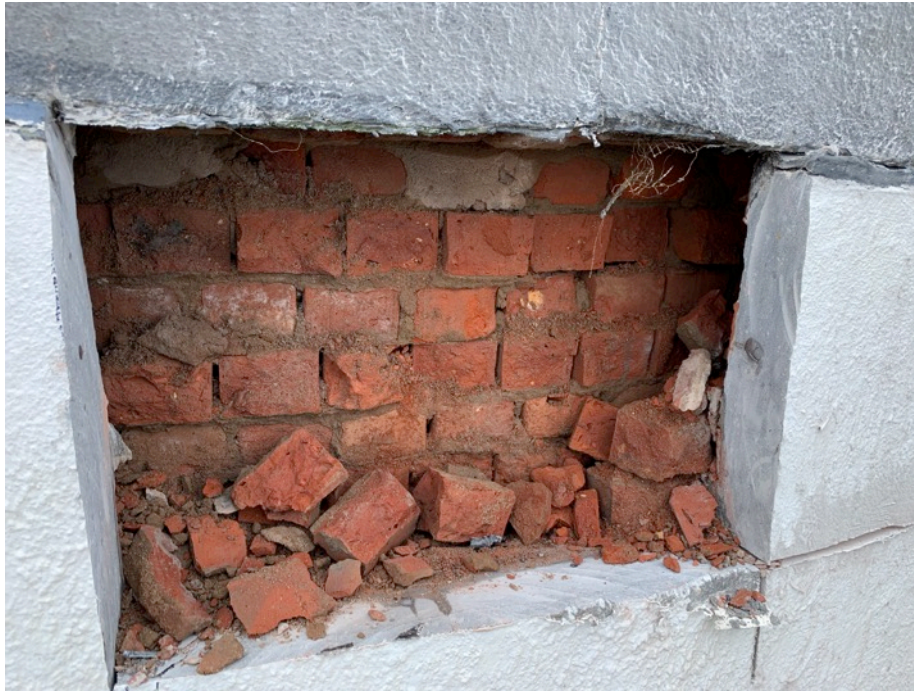
Photograph #3

Removal of concrete revealed that the exterior wythe of the brick masonry is loose, deteriorated, and/or no longer integral with the brick structure directly behind.

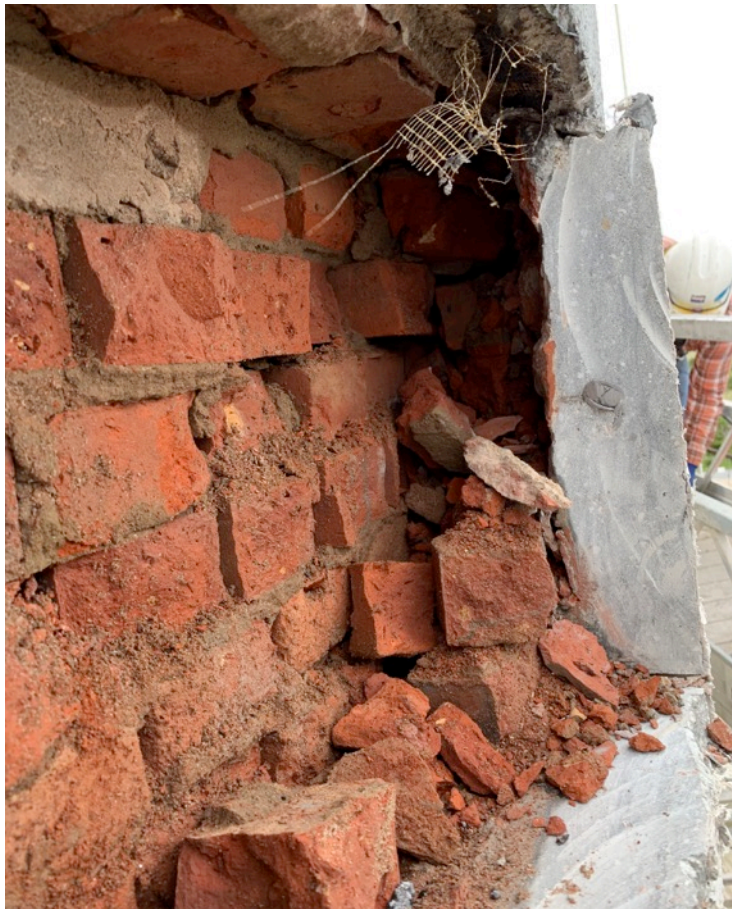
Photograph #4

The exterior wythe of the brick masonry is loose, deteriorated, and/or no longer an integral part of the brick structure directly behind.

The brick masonry and the mortar at this level were both damp. The mortar has the consistency of sand and has limited binder.

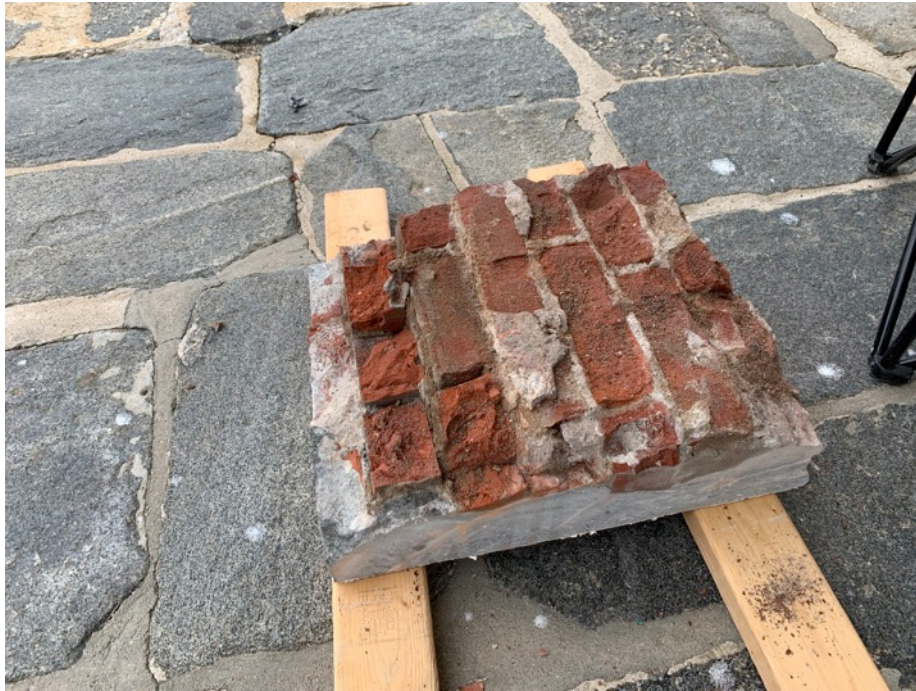
Photograph #5

A sample of the concrete shell with brick masonry attached removed from the top of Ring 1, which is a typical condition at the destructive probe.

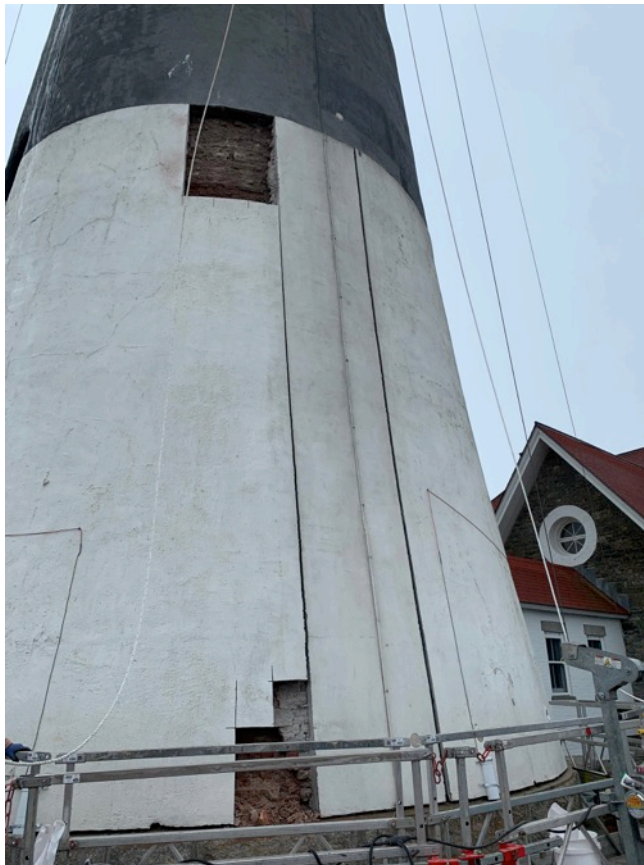
Photograph #6

Overview of concrete shell removal at the end of the day.

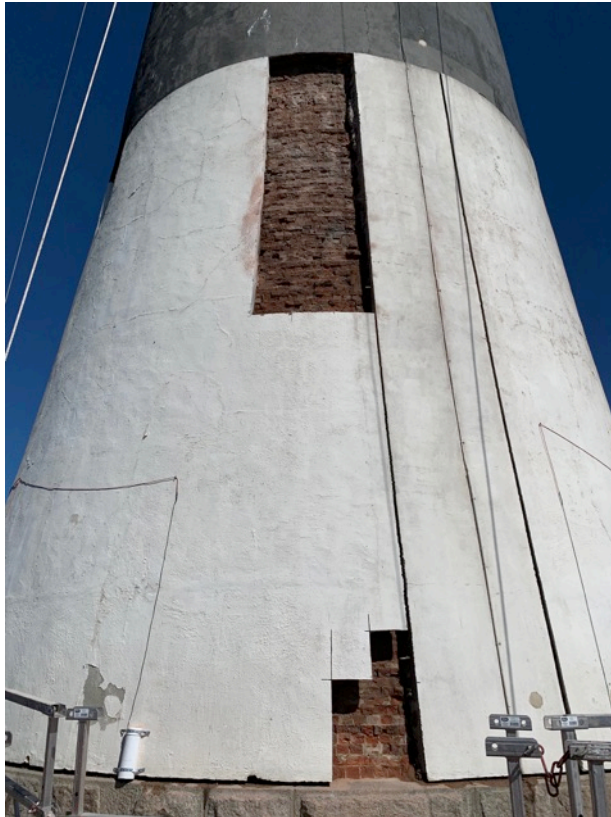
Photograph #7

Overview of concrete removal at the end of the day.

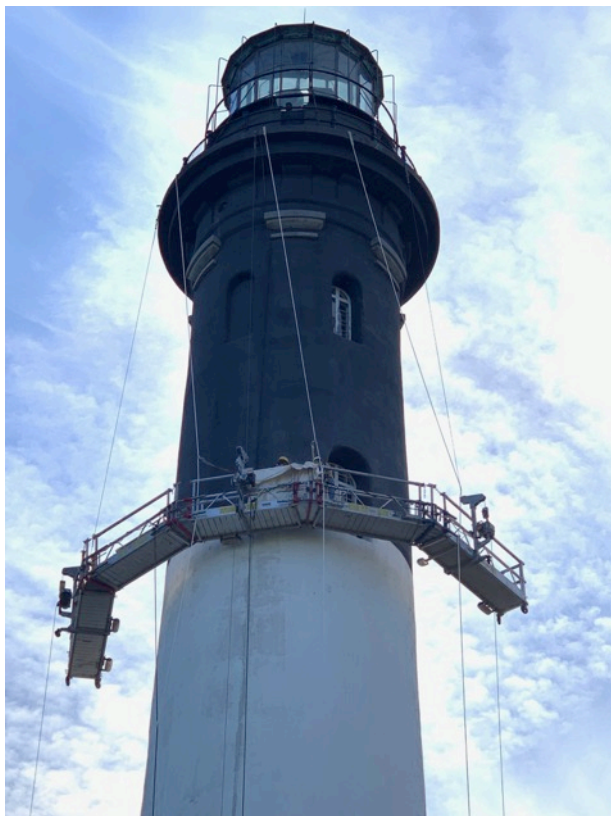
Photograph #8

- c) Apple removed a 2' x 2' portion of the concrete shell at the west, adjacent to the 5th landing of the lighthouse for flat jack testing. (Photo #8)

Overview of the
lighthouse during
concrete shell
removal at the
exterior of the 5th
floor landing for flat
jack testing and
sample collection.

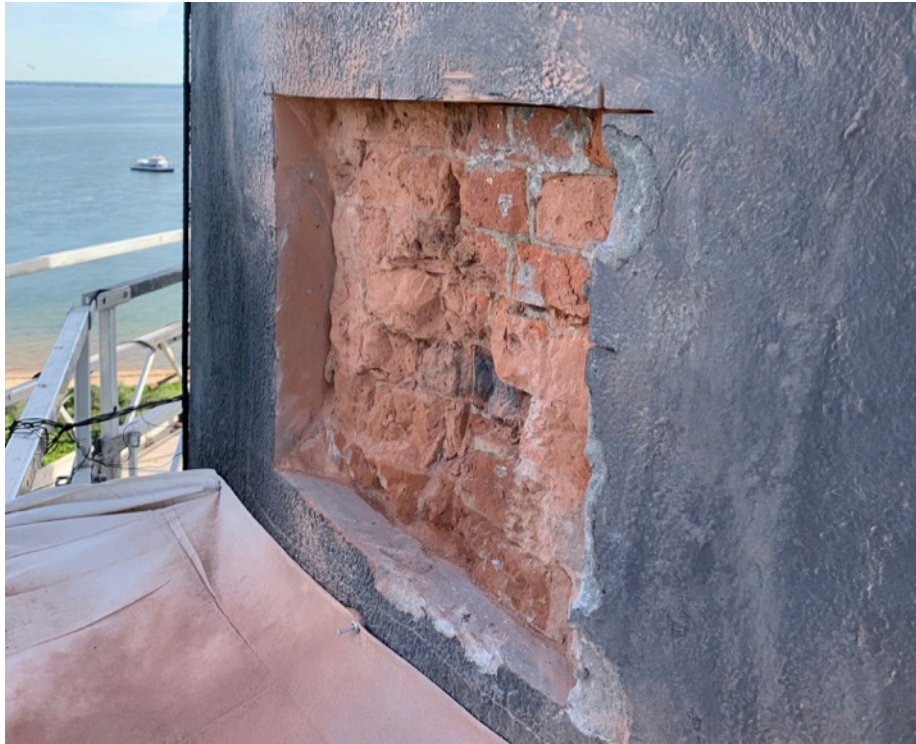
Photograph #9

- (1) At least the exterior half of the exterior wythe of the brick masonry was removed with the concrete shell. The remaining portion of the wythe was removed to allow for flat jack testing. (Photo #9)

The concrete shell has been removed; the first wythe was partially removed with the concrete shell.

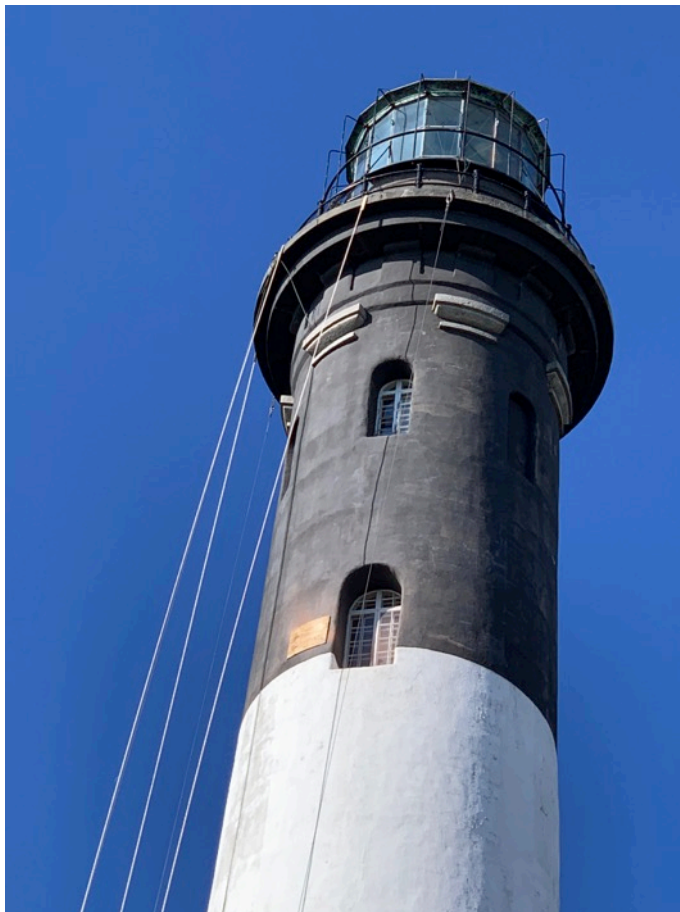
Photograph #10

- (2) Pressure-treated plywood was mechanically fastened to the face of the lighthouse to cover the removal area. (Photo #10)
 - d) Apple completed the removal of the concrete shell at the large Northwest removal area at ring one (Photo #11)

A pressure-treated piece of plywood was fastened to the exterior of the concrete shell at the removal location.

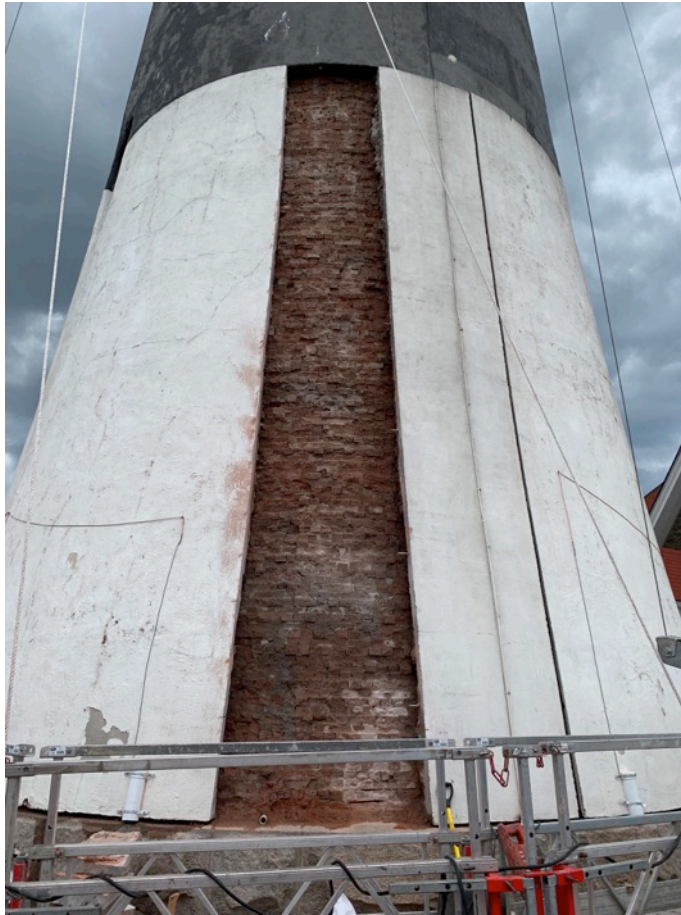
Photograph #11

Overview of concrete removal at the end of the day.

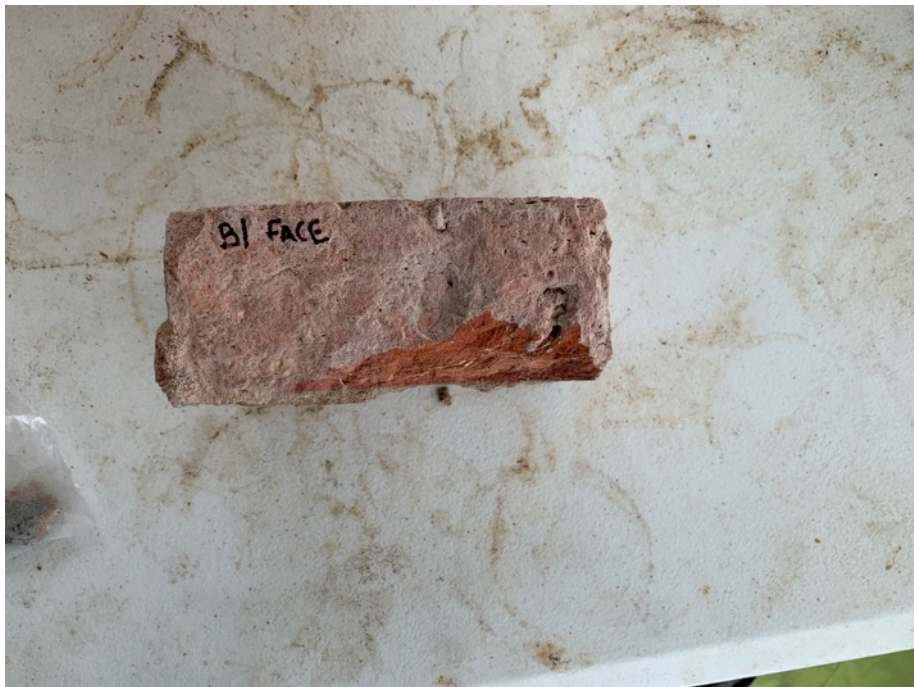
Photograph #12

Apple removed a piece of masonry from the base of the outer wythe. This is one of the most intact samples with a known exterior face.

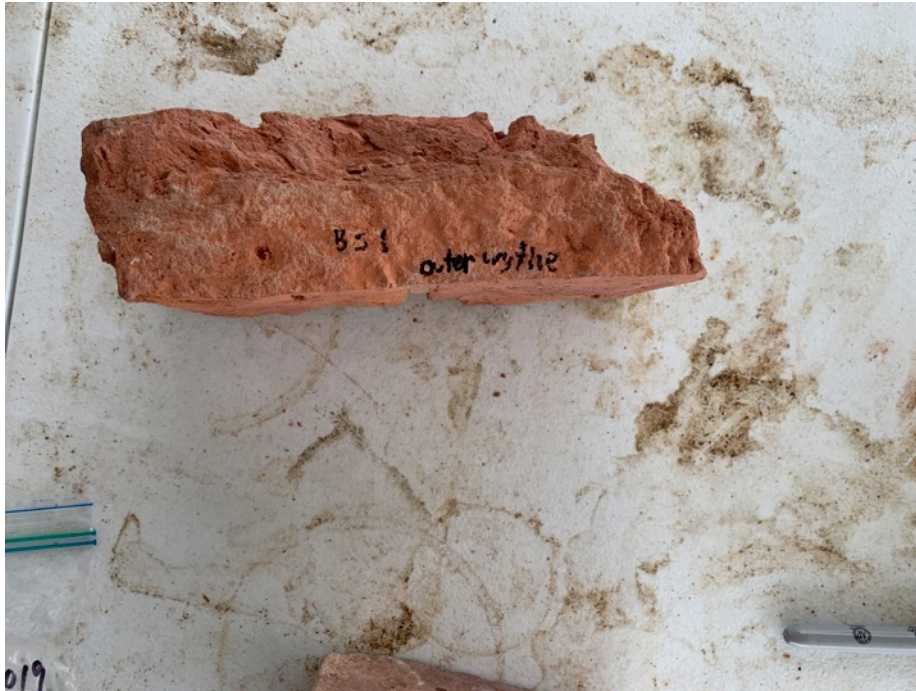
Photograph #13

Apple removed a piece of masonry from the base of the outer wythe. This piece of masonry contains a full mortar bed with approximately one inch of brick masonry on either size of the mortar joint.

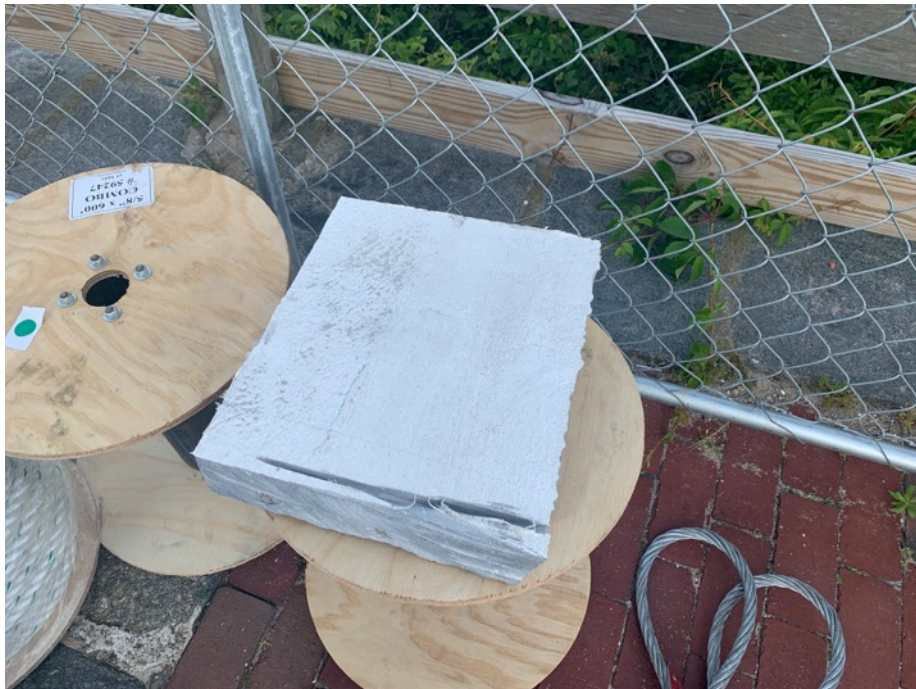
Photograph #14

Apple removed a piece of cementitious material from the base of the lighthouse at the west side.

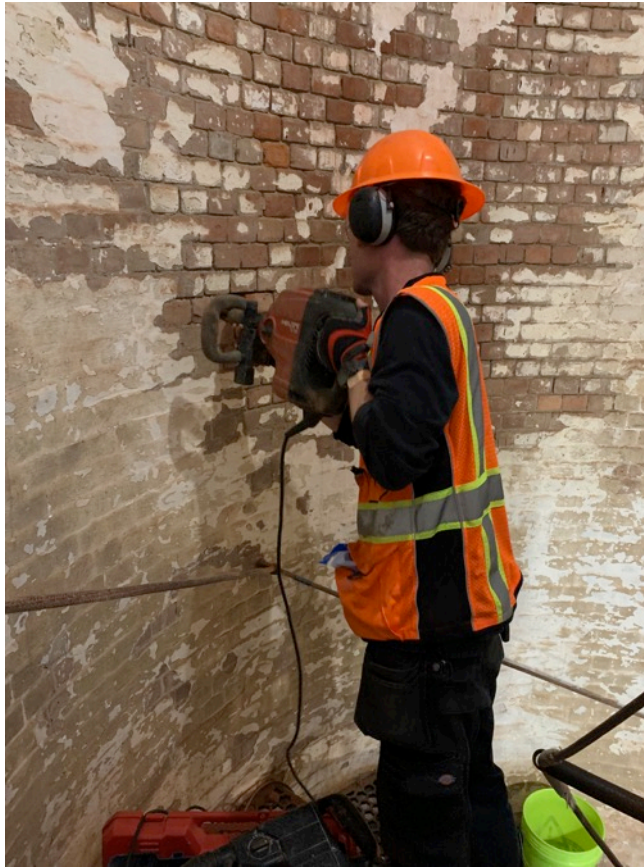
Photograph #15

Apple began brick
sample collection at
the interior of the
lighthouse, removing
the specified brick
masonry.

All bricks that were
removed and are not
being utilized for
samples are to be re-
installed using Type N
mortar by Apple.

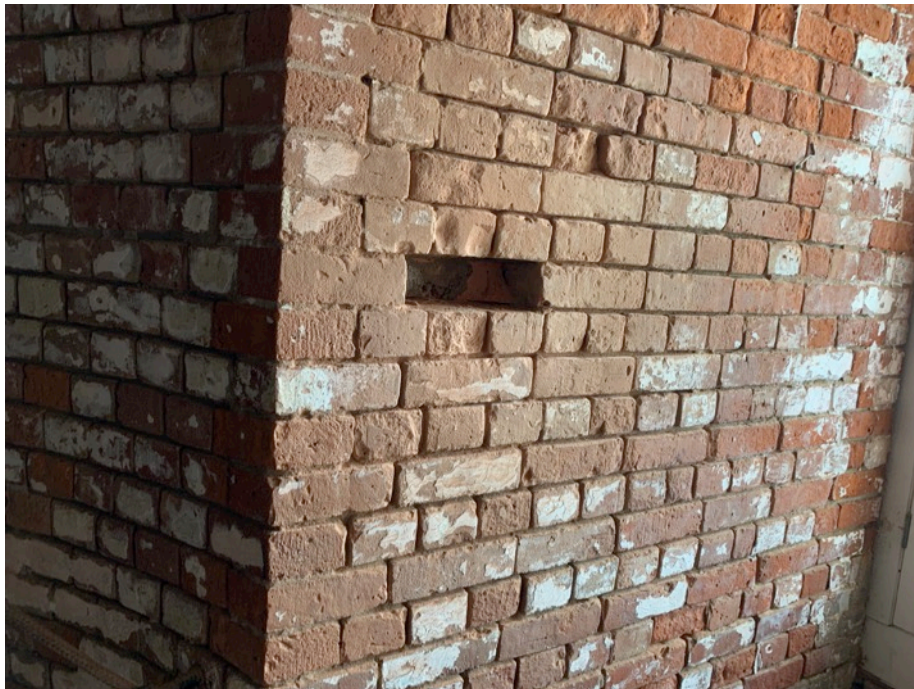
Photograph #16

Area of brick removed
for testing.

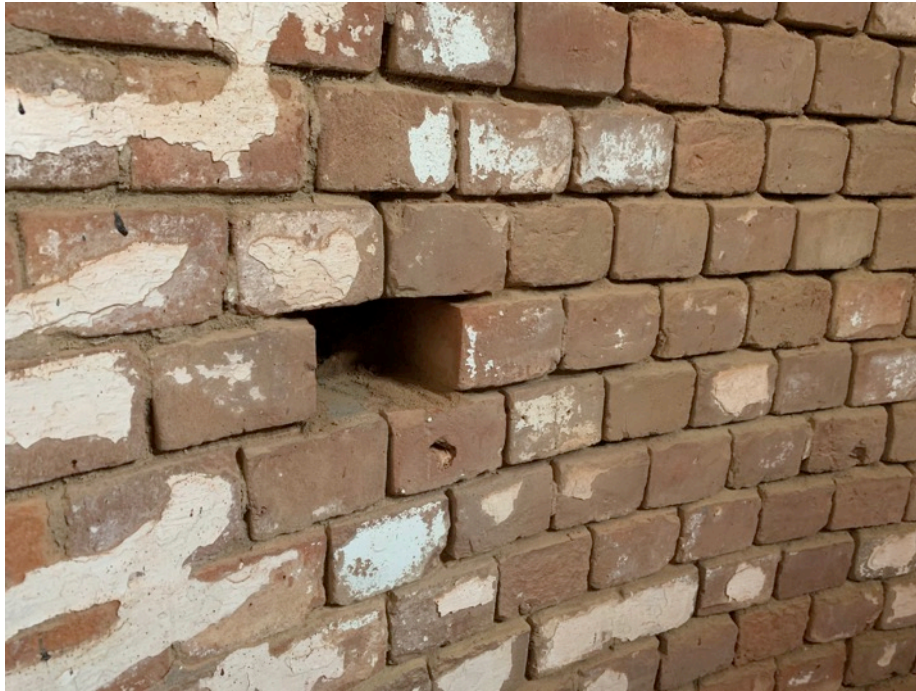
Photograph #17

Area of brick removed for testing.

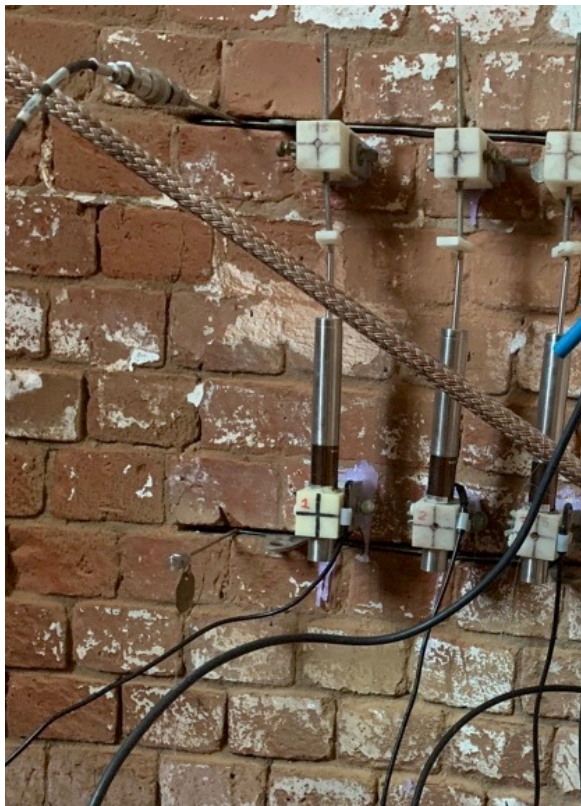
Photograph #24

Cracking at brick
masonry during flat
jack testing.

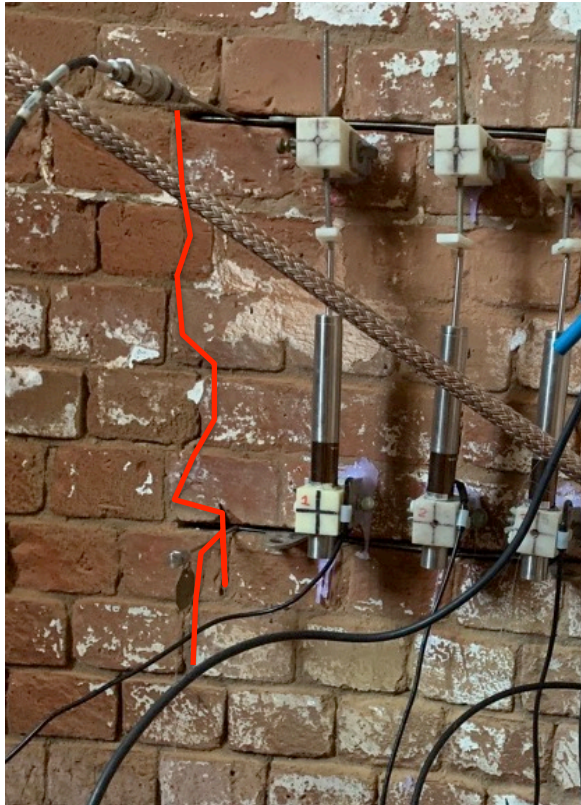
Photograph #25

Cracking at brick
masonry during flat
jack testing.
