**APPENDIX A: SITE PHOTOS**

Project No. [REDACTED]

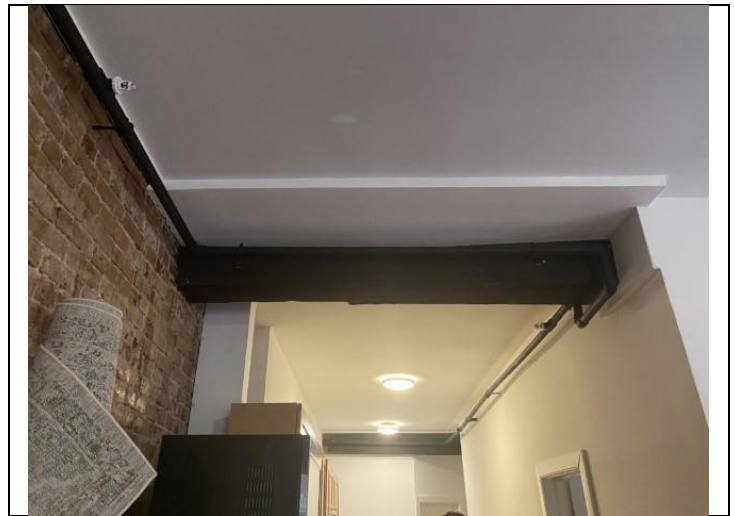
16. Typical exposed heavy timber girder beam in an apartment with acceptable shrinkage cracking.

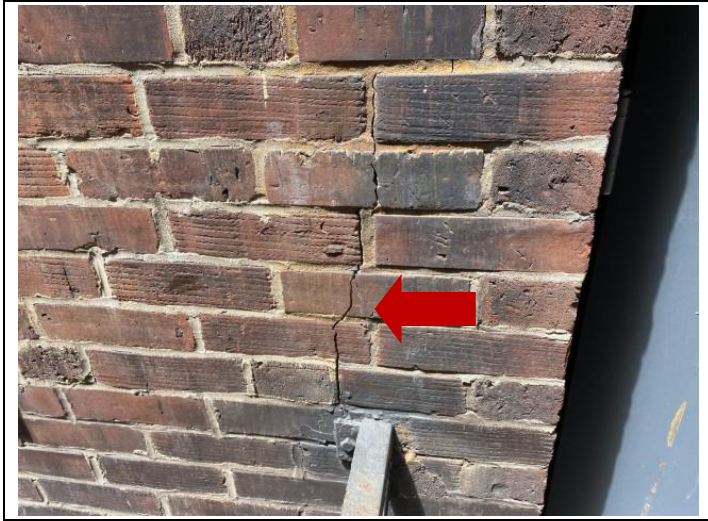
25. Cracking observed on Building B exterior wall.

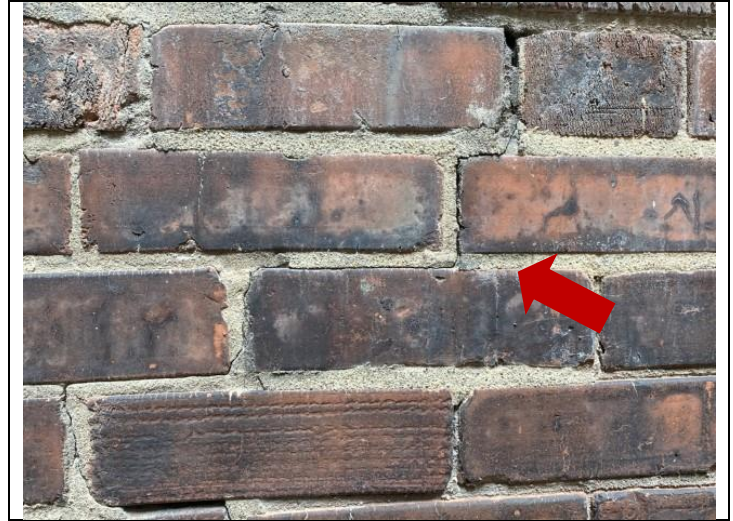
26. Stair-stepped cracking observed on Building B exterior wall.

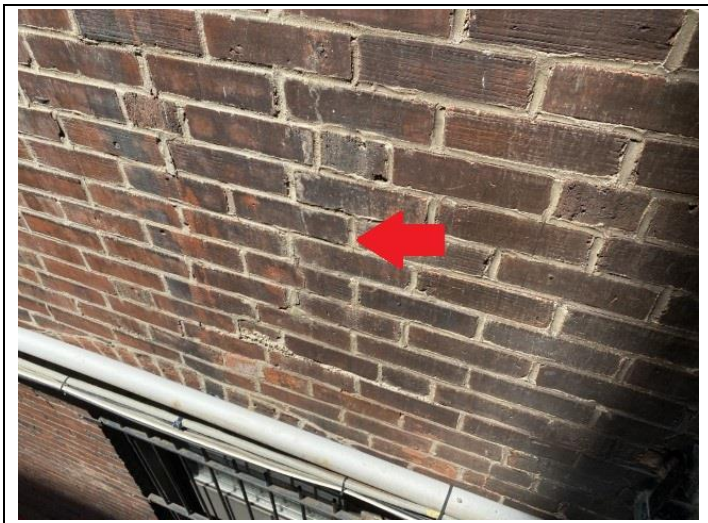
27. Additional stair-stepped cracking observed on Building B.

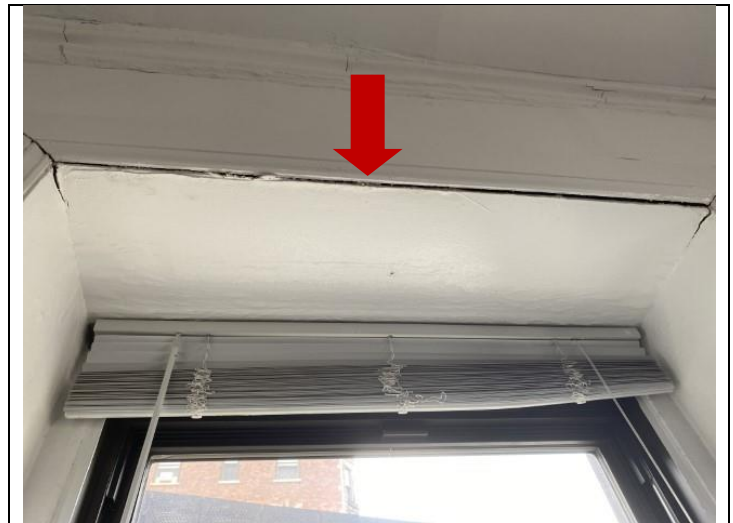
28. Large cracks in Building B window frame indicative of foundation settlement.

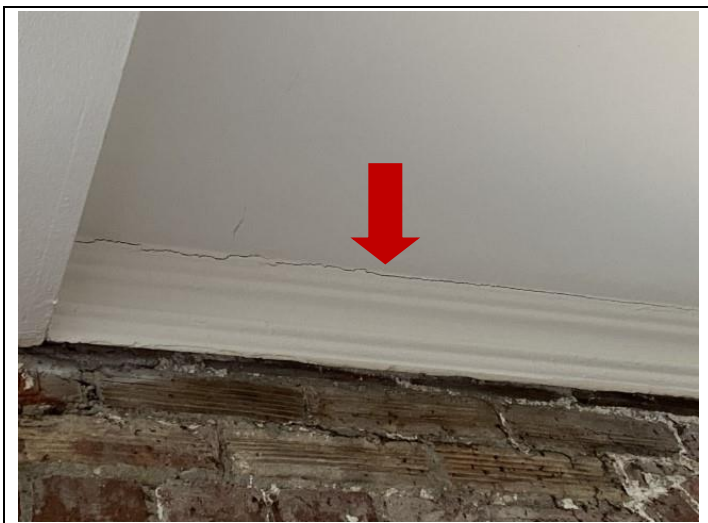
29. Hairline crack visible in apartment ceiling finish.

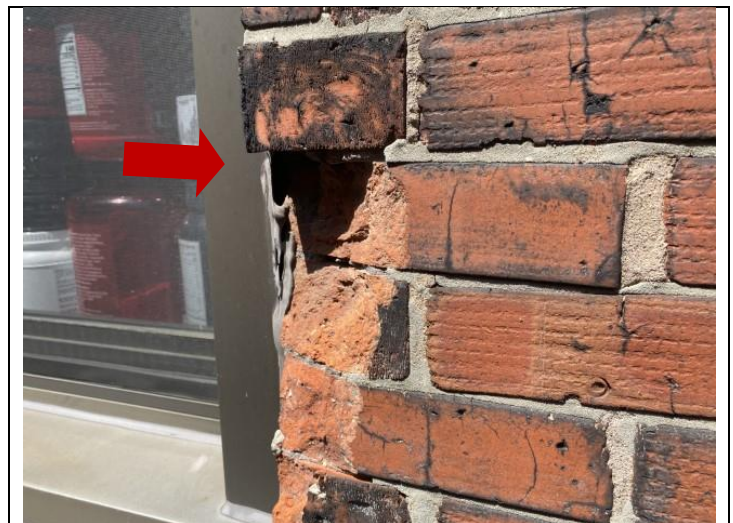
30. Typical section of spalling in exterior brick masonry.

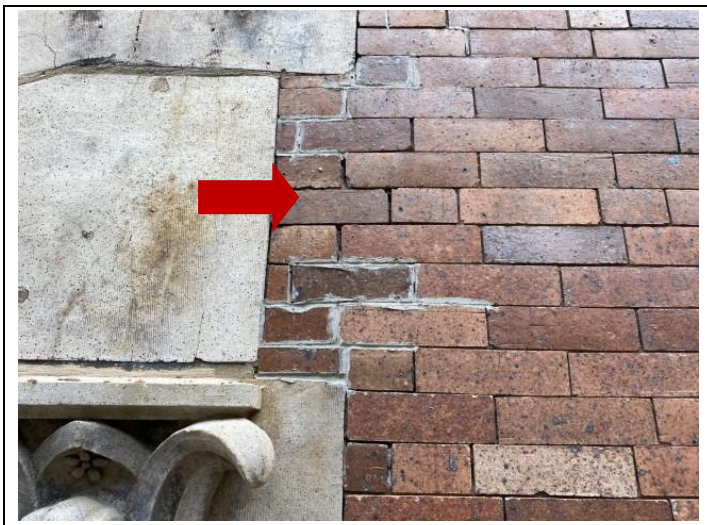
31. Typical open mortar joints on exterior brick masonry.

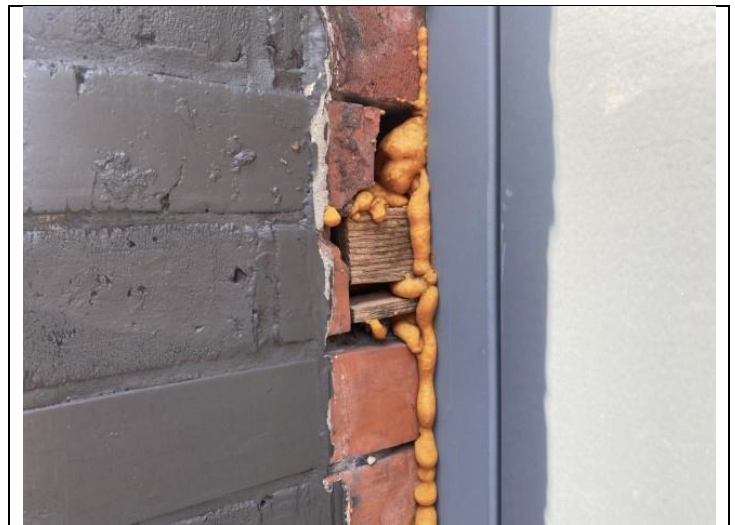
32. Typical failing repair for spalled and missing brick consisting of expanding foam and wood blocking.

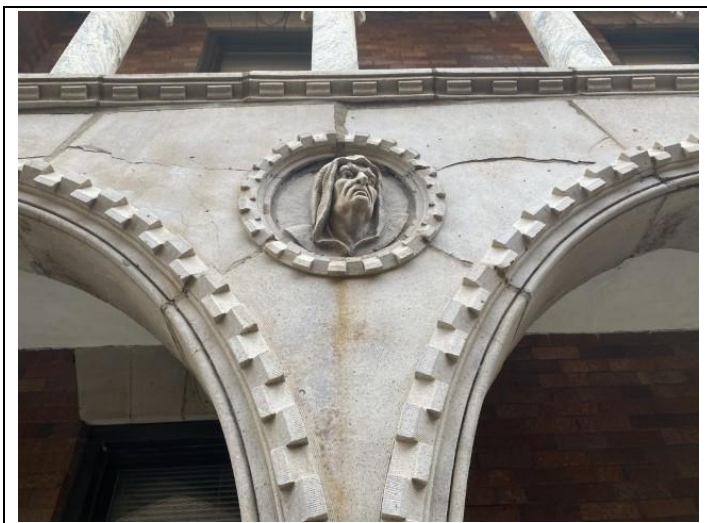
33. Typical cracking in decorative stonework in the east courtyard.

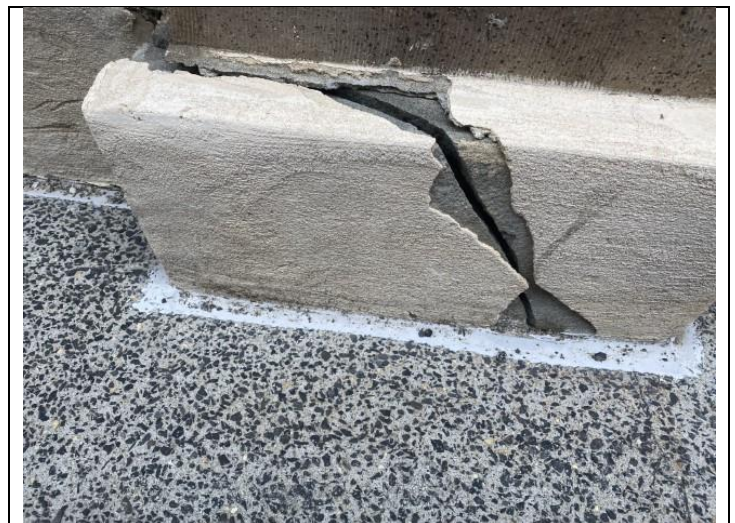
34. Large crack in decorative stonework base.

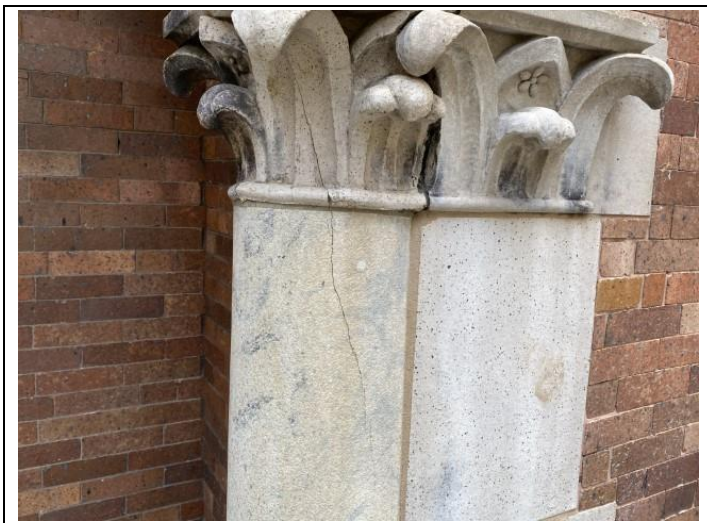
35. Hairline crack in decorative stonework column.

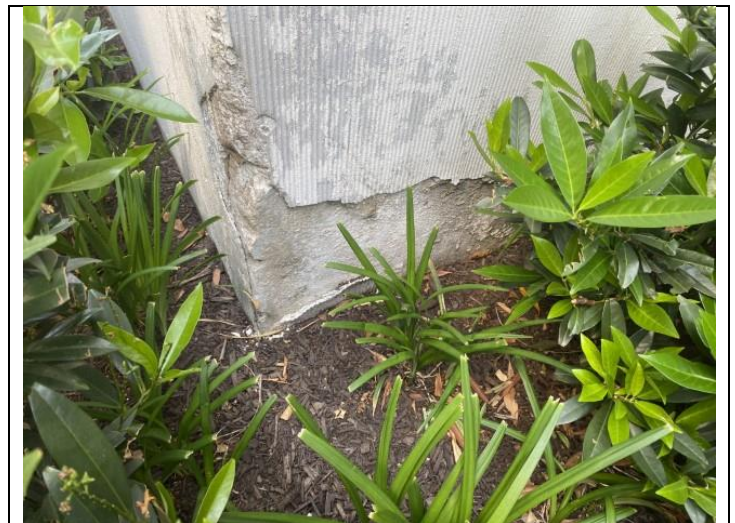
36. Spalled parging on Building A.

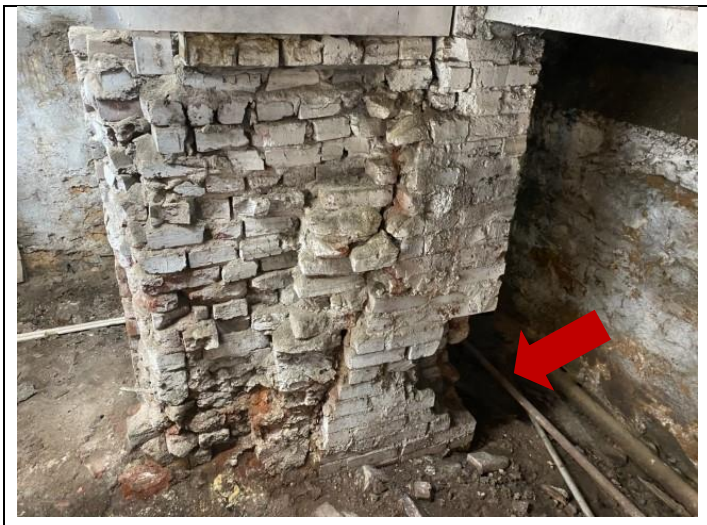
37. Distressed foundation wall with large crack on the side observed in Buildings G and H.

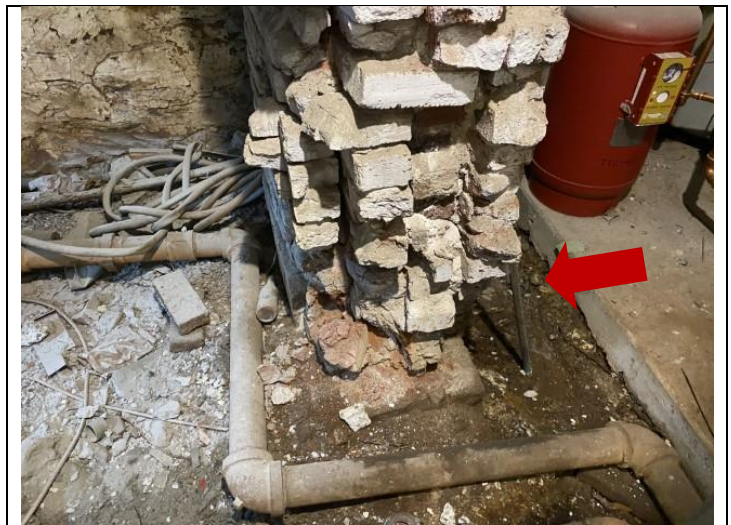
38. Distressed foundation wall with extensive spalling brick observed in Buildings G and H.

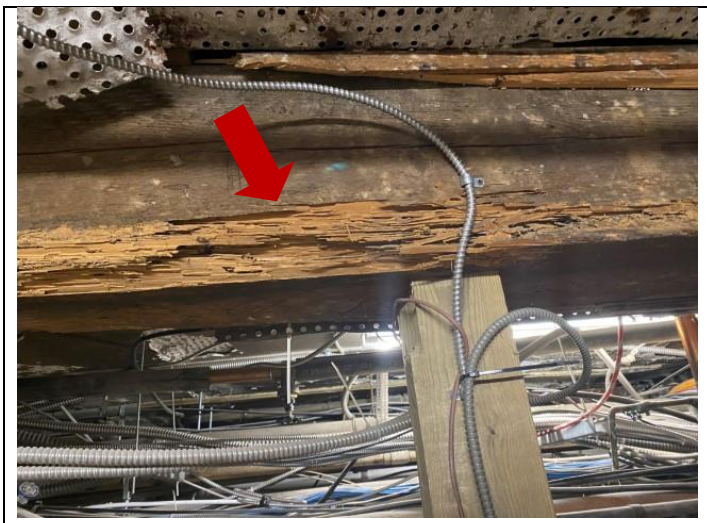
39. Termite-damaged wood beam in Building G and H basement.

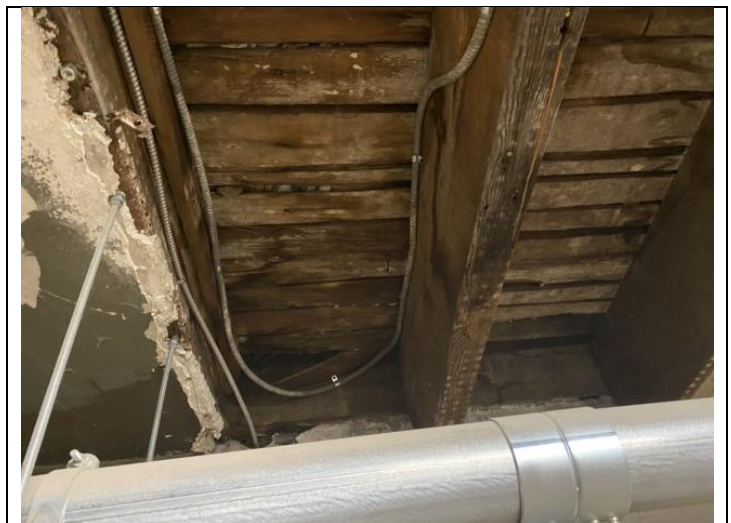
40. Water damaged and rotting wood floor joists visible in the Building G/H basement.

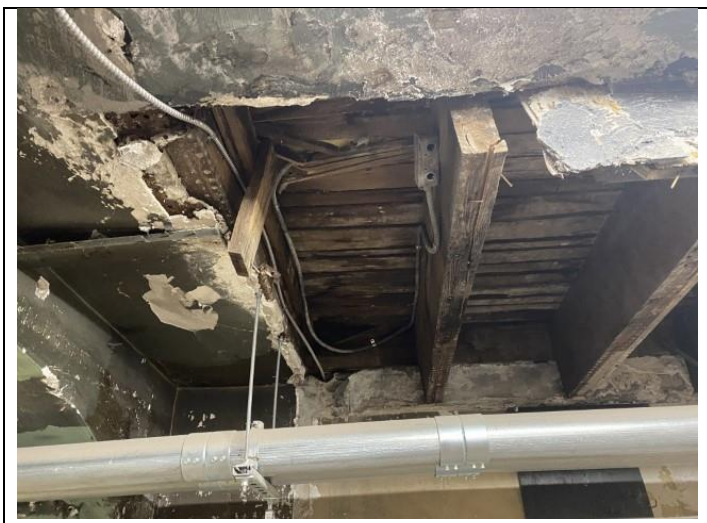
41. Snapped wood plank floor and joist visible from the Building G/H basement.

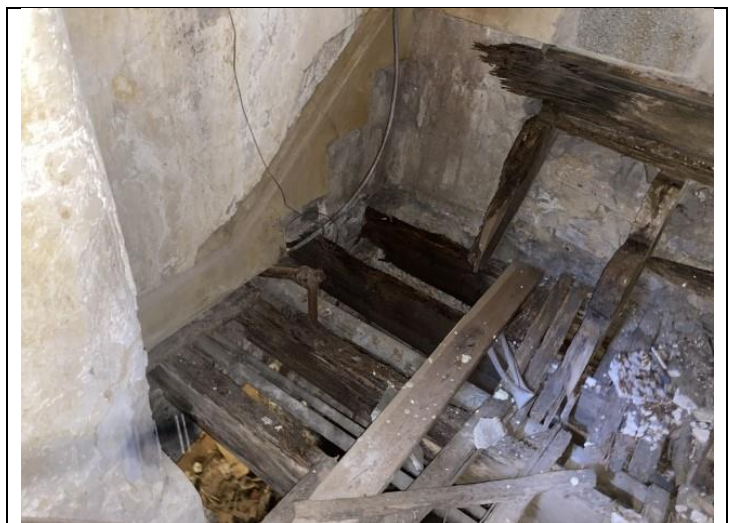
42. Rotted out wood plank flooring and joists in Buildings G/H basement.

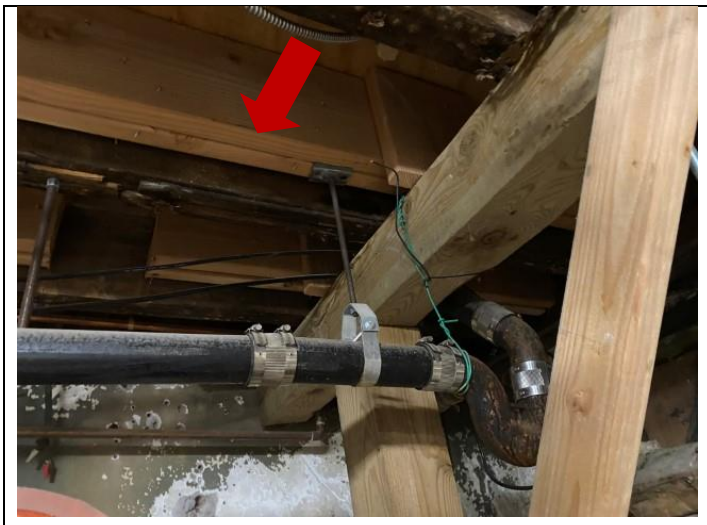
43. Sistered wood floor joists.

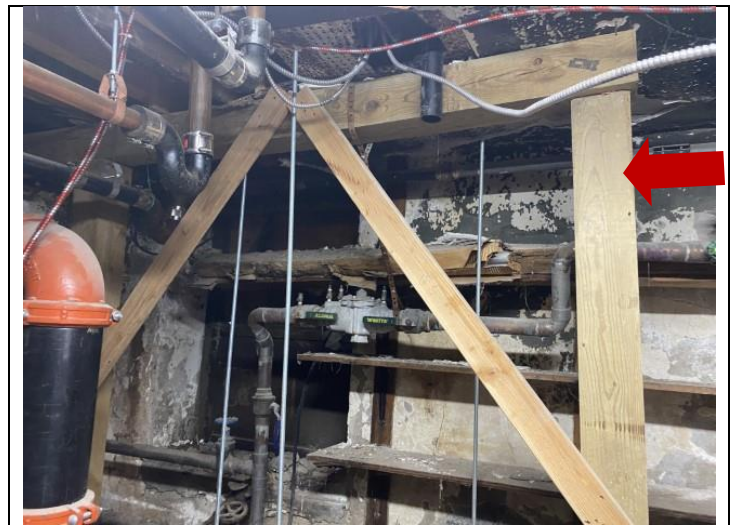
44. Retrofit wood columns and cross bracing that is not reflected on the structural bid set for Buildings G and H.

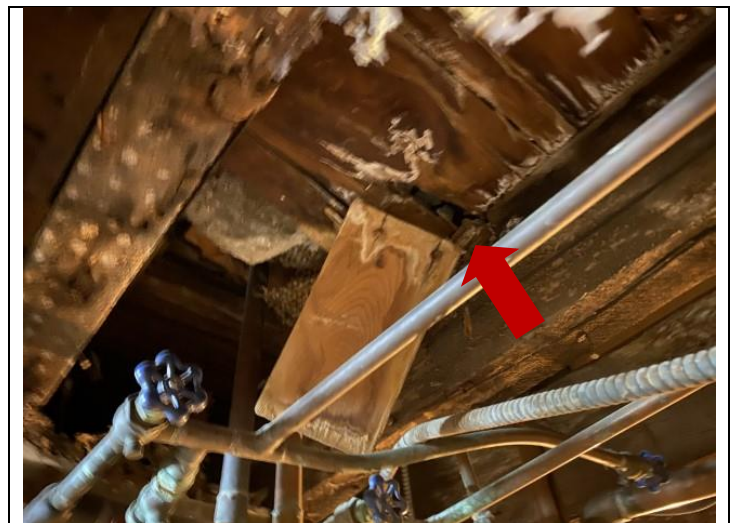
46. Rotting joists and decking in Building D.

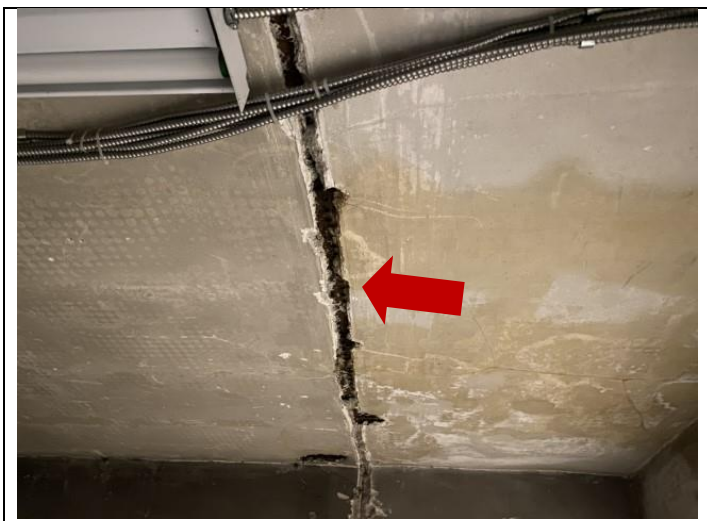
47. Cracking observed in Building D basement ceiling.

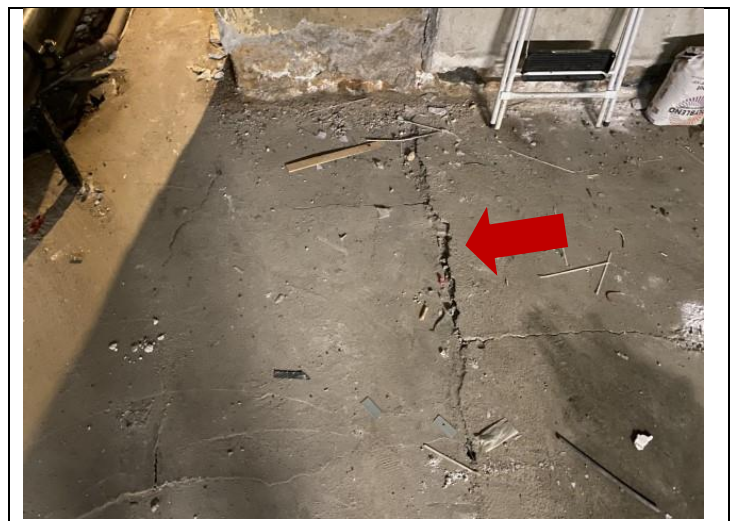
48. Cracking observed in Building D basement concrete slab.

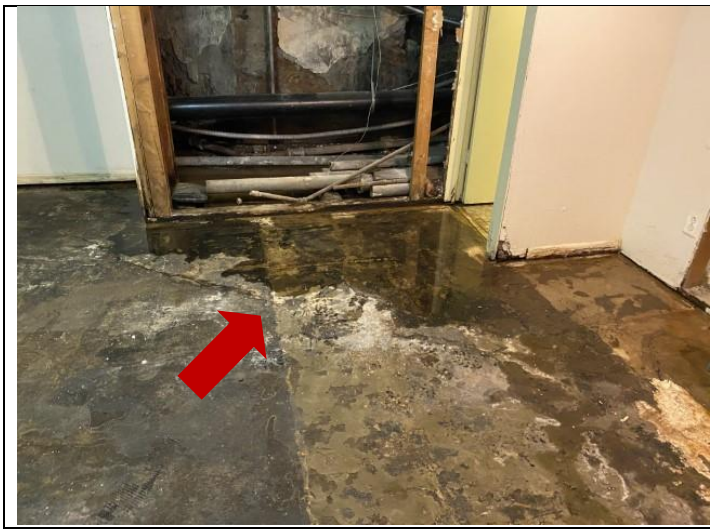
49. Standing water observed in the basement of Building D.

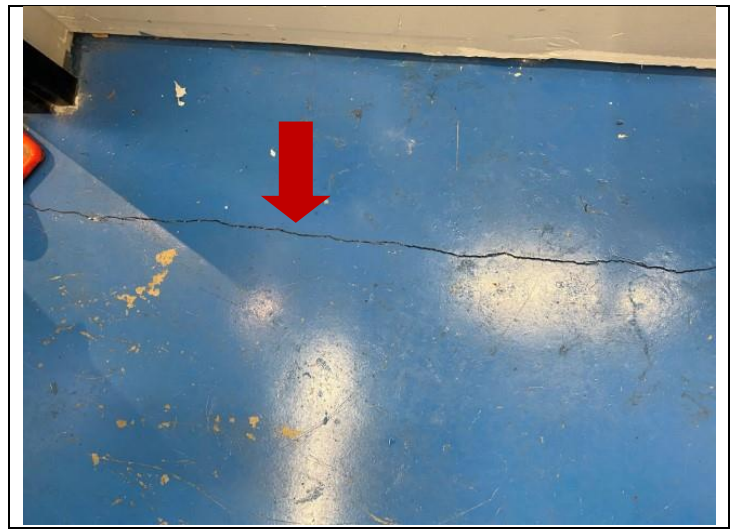
50. Concrete floor shrinkage cracking observed in the Amenity Building pool/spa mechanical space.

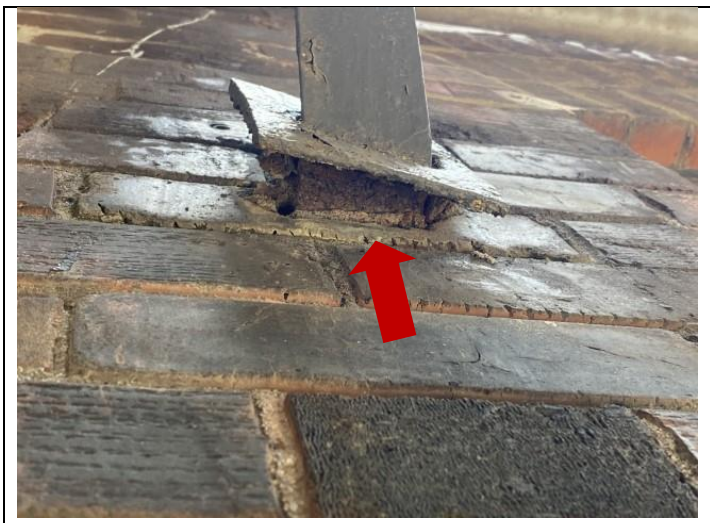
51. Typical egress balcony support separating from exterior masonry wall.

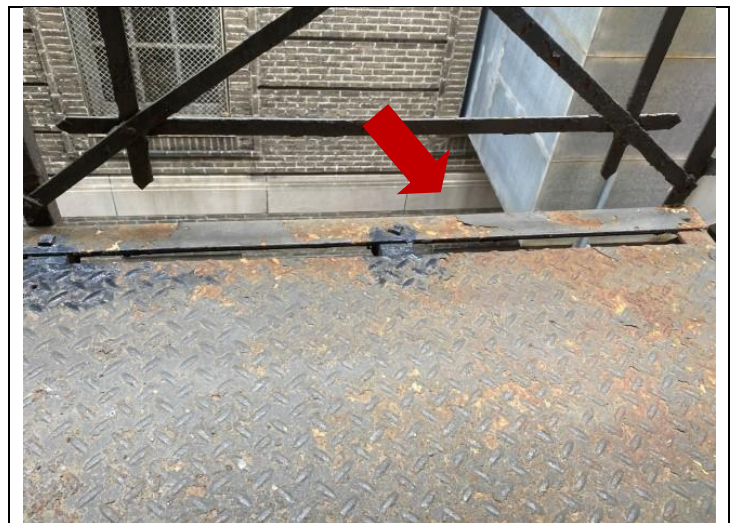
52. Typical corrosion found on egress balconies.

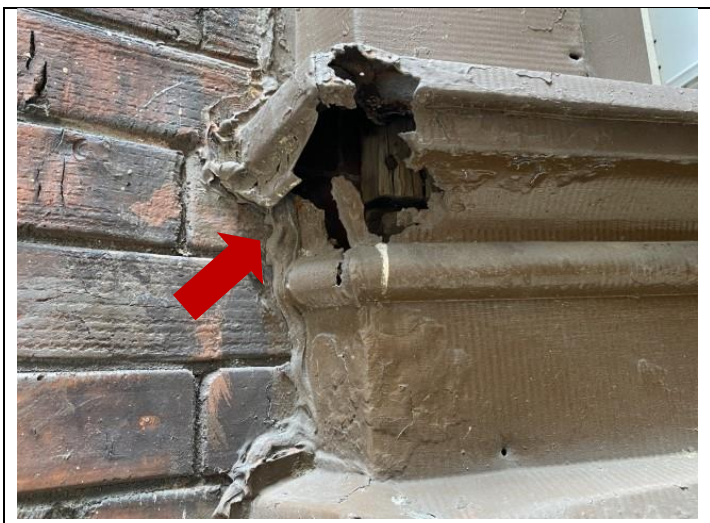
53. Typical void in rear bay window frame.

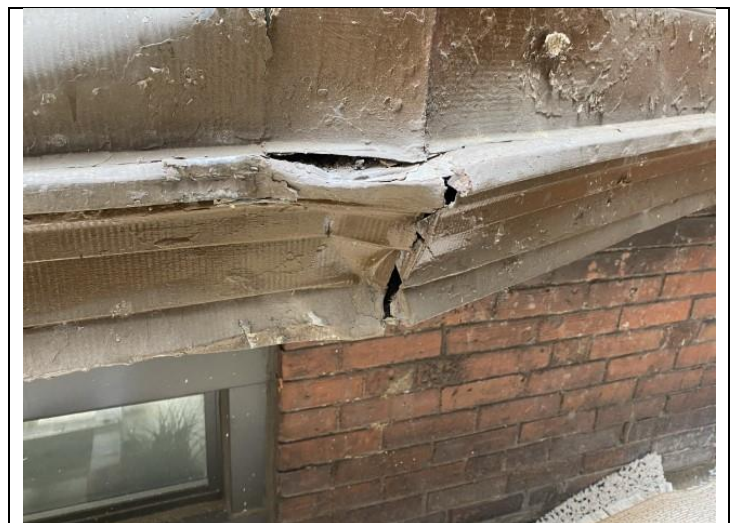
54. Typical cracking in rear bay window frame.

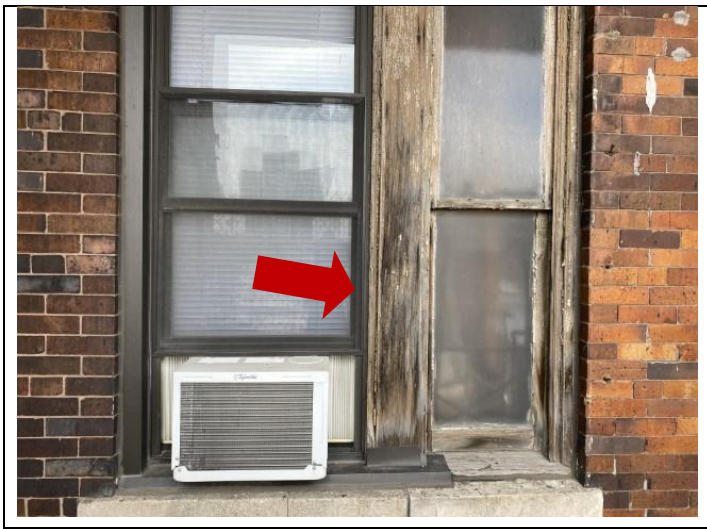
55. Typical decayed wooden window frame with several points for potential moisture intrusion.

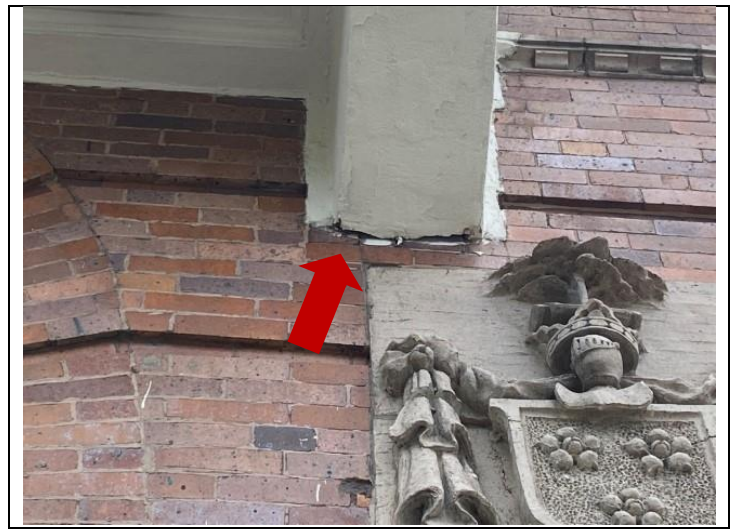
56. Typical void between diagonal balcony support and masonry wall on Buildings A and K.

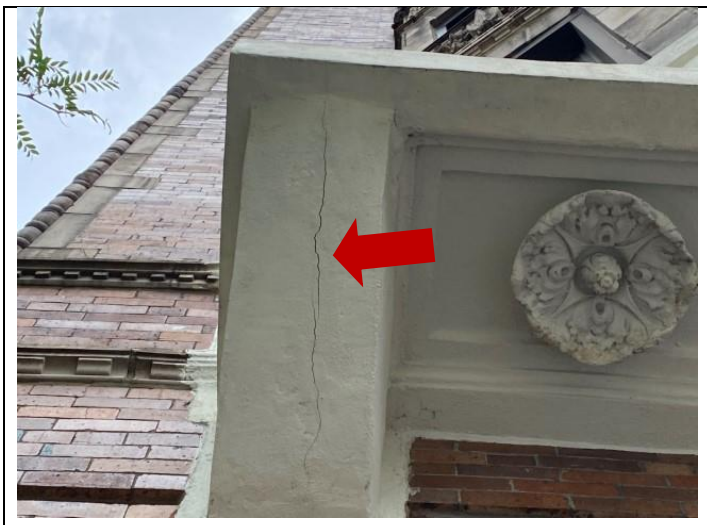
57. Hairline cracking observed on the left balcony on Building A.

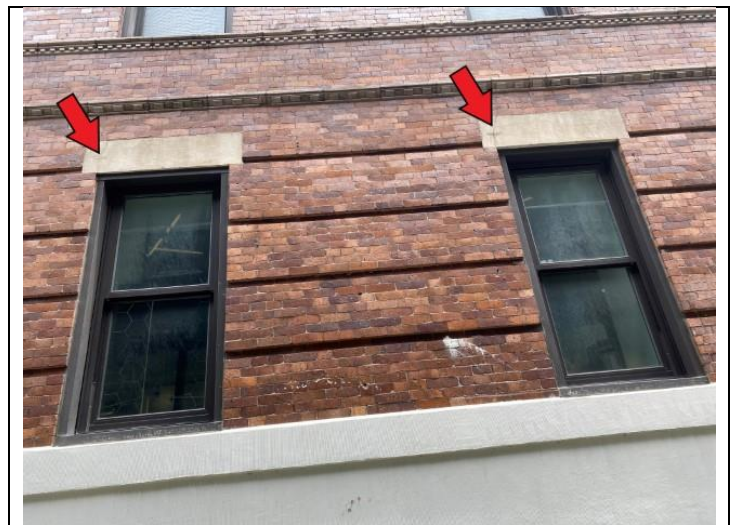
58. Typical cracks in window lintels with previous epoxy injection repair visible.

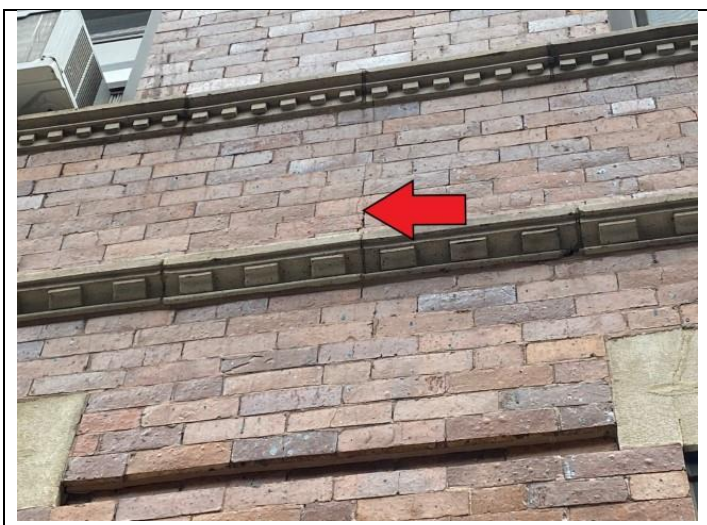
59. Typical vertical cracking in brick spandrels.

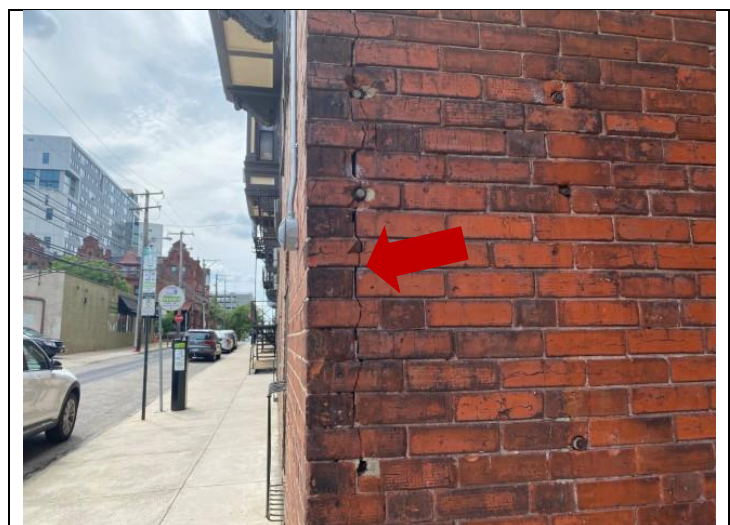
60. Vertical cracking at the rear of Building G.
