**The New York Landmarks Conservancy
Lucy G. Moses Preservation Awards
Submittal**

**Rod Rodgers and Duo Multicultural Arts Center
62 East 4th Street
New York, New York**

Exterior Restoration

An Unconventional East Village Landmark Restored

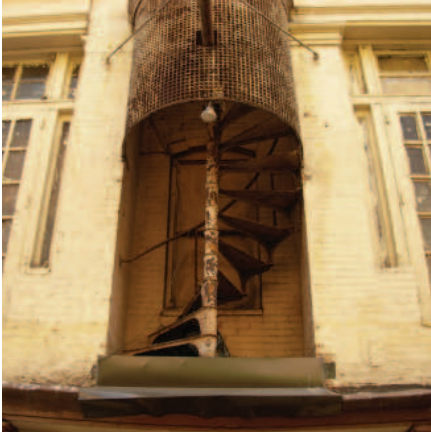
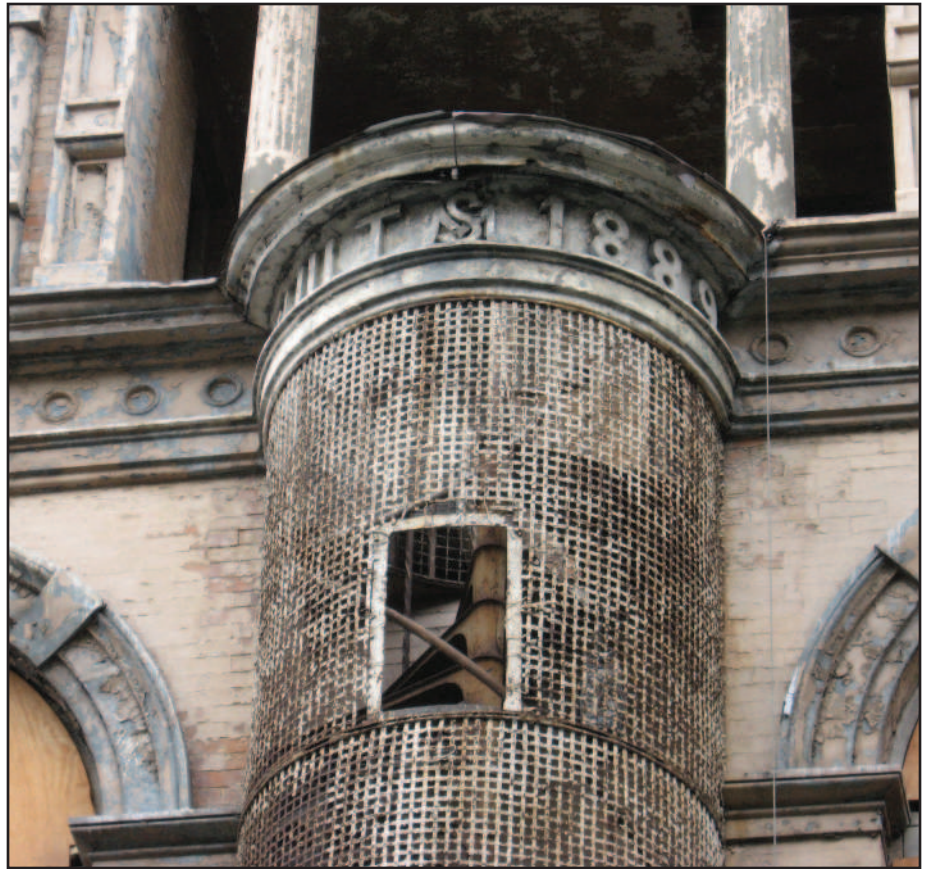
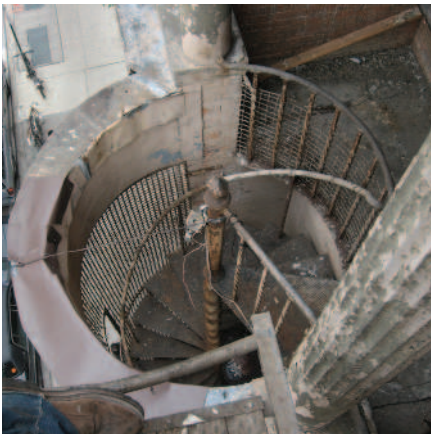
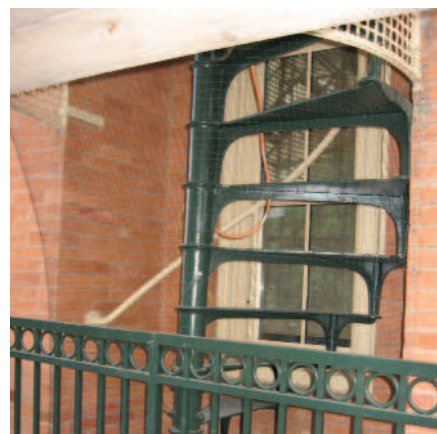
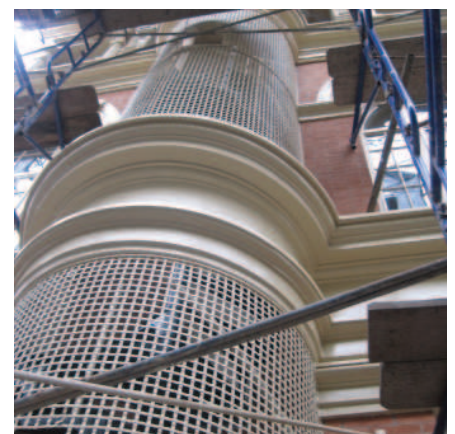
Front Spiral Staircase and Rear Fire Escape

It was discovered that the steel supporting the circular iron fire escape stairway on the front facade of the building was extremely deteriorated. The entire stairway was shored up to allow for replacement of the steel. Restoration of the staircase also involved cast iron and steel repairs to cracked and missing sections, though nearly all of the original fabrication was retained. The deteriorated rear fire escape was replaced with a new steel stair. Paint analysis guided the final coating of the staircase and lattice cage, which were meticulously scraped of all existing rust.

Top, left and right; bottom, left: Spiral stair and lattice cage before restoration. Bottom, center and right: Spiral stair and lattice cage after restoration.

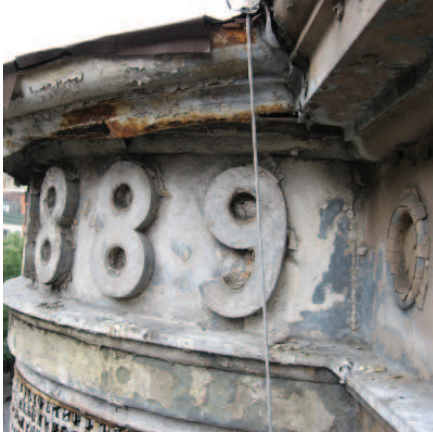
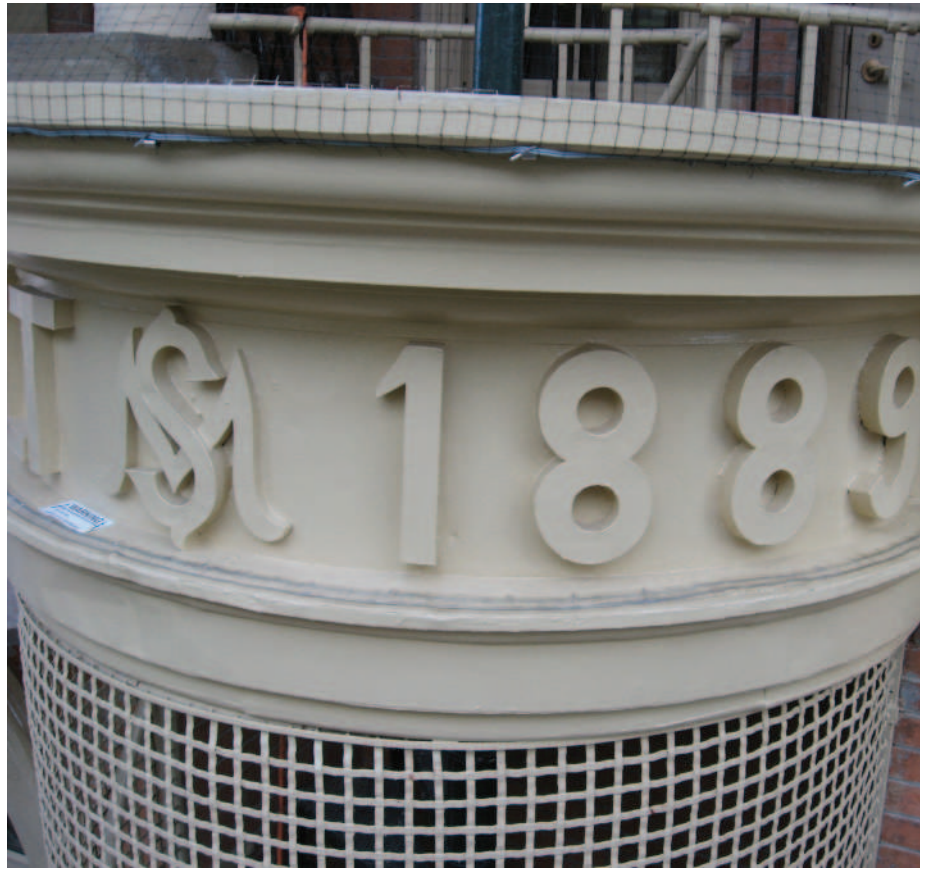
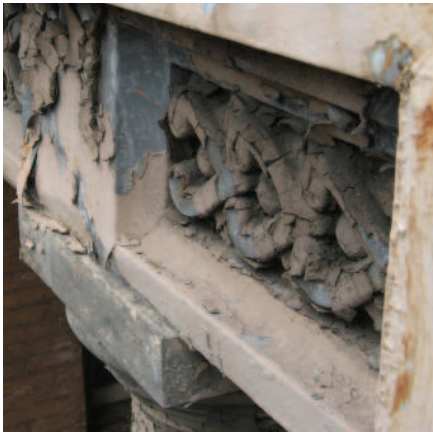
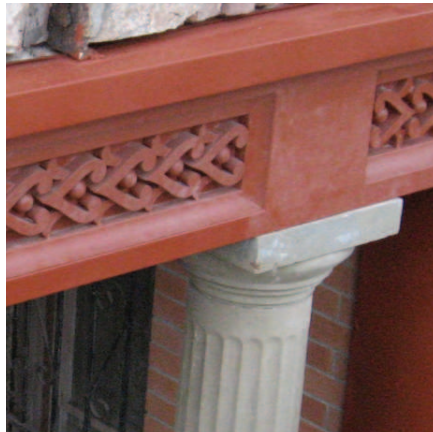
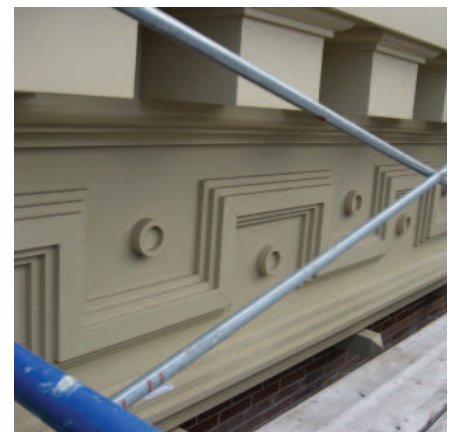
Sheet Metal Restoration and Cornice Recreation

The cornice missing from the top of the building was re-designed using a tax photo from 1948 (which appears on the first page of narrative above). All ornamental steel bandcores were repaired or replaced when not salvageable. Color matching was done for all the paint used on the restored and replaced sheet metal work. The ornamental detailing on the stamped metal lintel above the columns on the fourth floor loggia was removed, cleaned and reinstalled on a new sheet-metal backup.

Top, left: Ornamental sheet metal before restoration. Top, right: Ornamental sheet metal, after restoration. Bottom, left: Lintel above 4th floor columns, before restoration. Bottom, center: Lintel above 4th floor columns, after restoration. Bottom, right: New cornice installed.

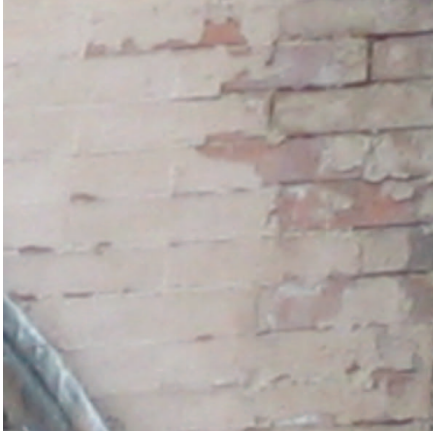
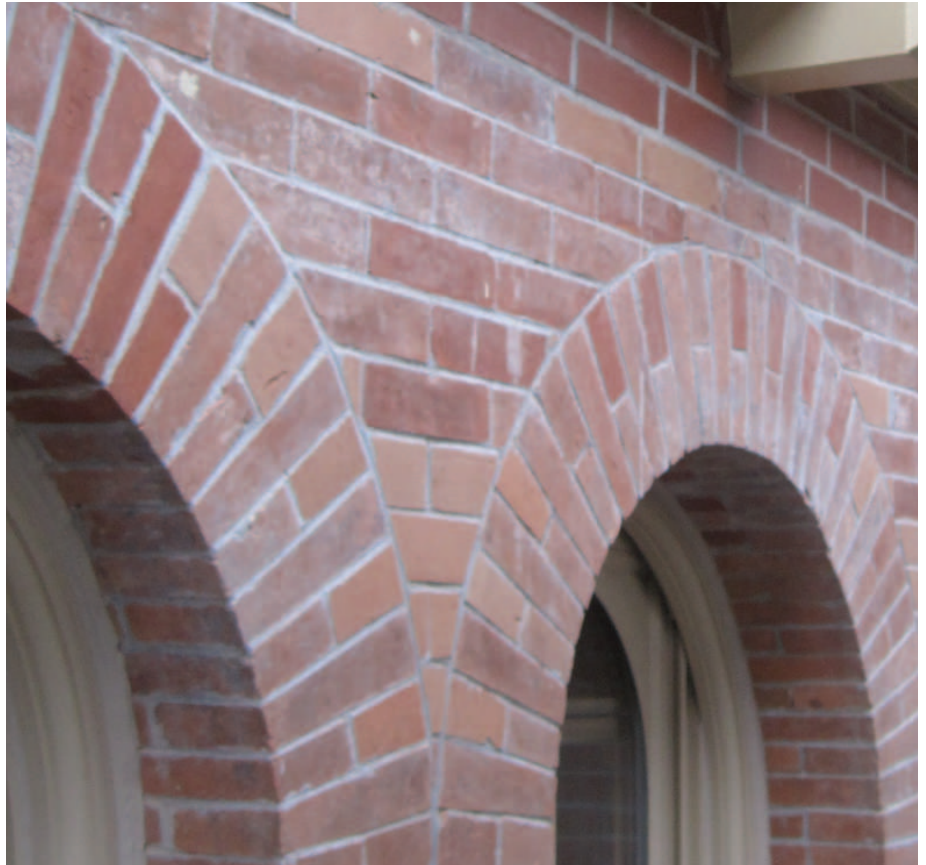
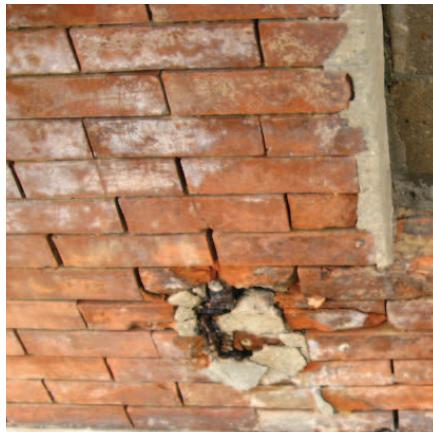
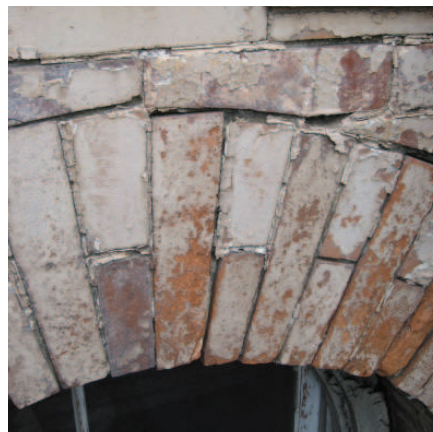
Masonry

The project involved stripping multiple layers of paint and coating from the brick walls. Deteriorated arches were rebuilt, defective masonry was replaced and abandoned elements were removed. Marquee boards were built into the masonry on the ground floor. Mockups were done as part of the process of re-finishing the brick masonry to achieve the best possible brick and mortar match.

Top, left; bottom, right and left: Brick wall before restoration. Top, right: After restoration.

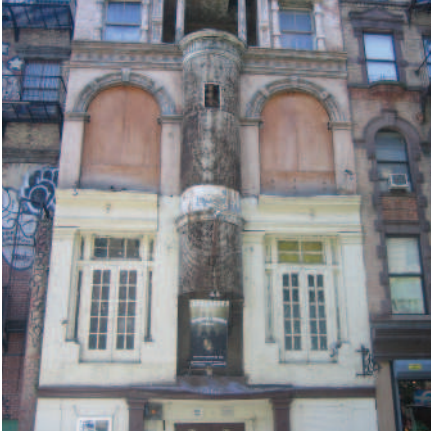
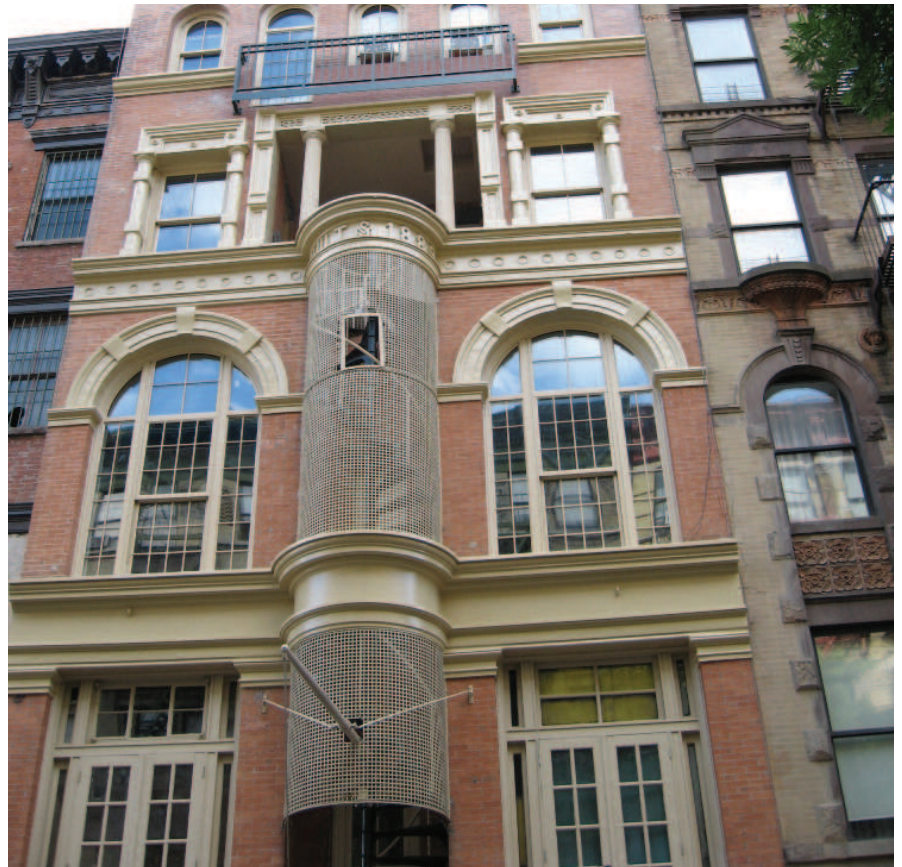
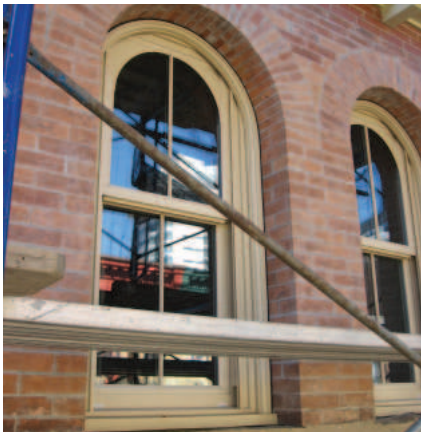
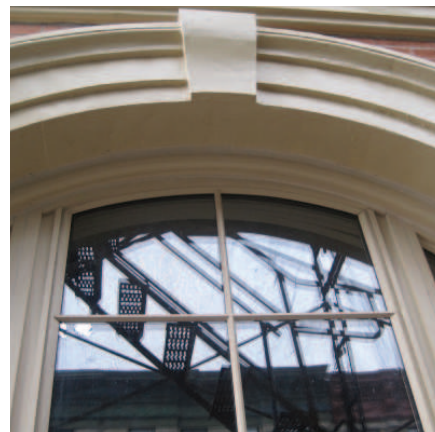
The French windows on the second floor are kalamein windows, comprising a core of wood covered with an exterior layer of metal for weather protection – this was also an early form of fire-proofing. For these windows sheet metal was repaired, and some glass was either reset or replaced. The remainder of the front facade windows were replaced with aluminum, the side and rear facade windows were originally steel or wood and were replaced with steel windows. The third floor windows had been removed and boarded over. Their design was recreated from photos and evidence on site.

Top, left: Windows before restoration. Bottom, left: Fifth-floor arched windows during restoration. Top and bottom, right: New windows installed.
