**The New York Landmarks Conservancy  
Lucy G. Moses Preservation Awards  
Nomination**

**George Westinghouse Career and Technical Education High School  
105 Tech Place  
Brooklyn, New York**

**Exterior Restoration**

**SUPERSTRUCTURES**  
+ **ENGINEERS  
ARCHITECTS**

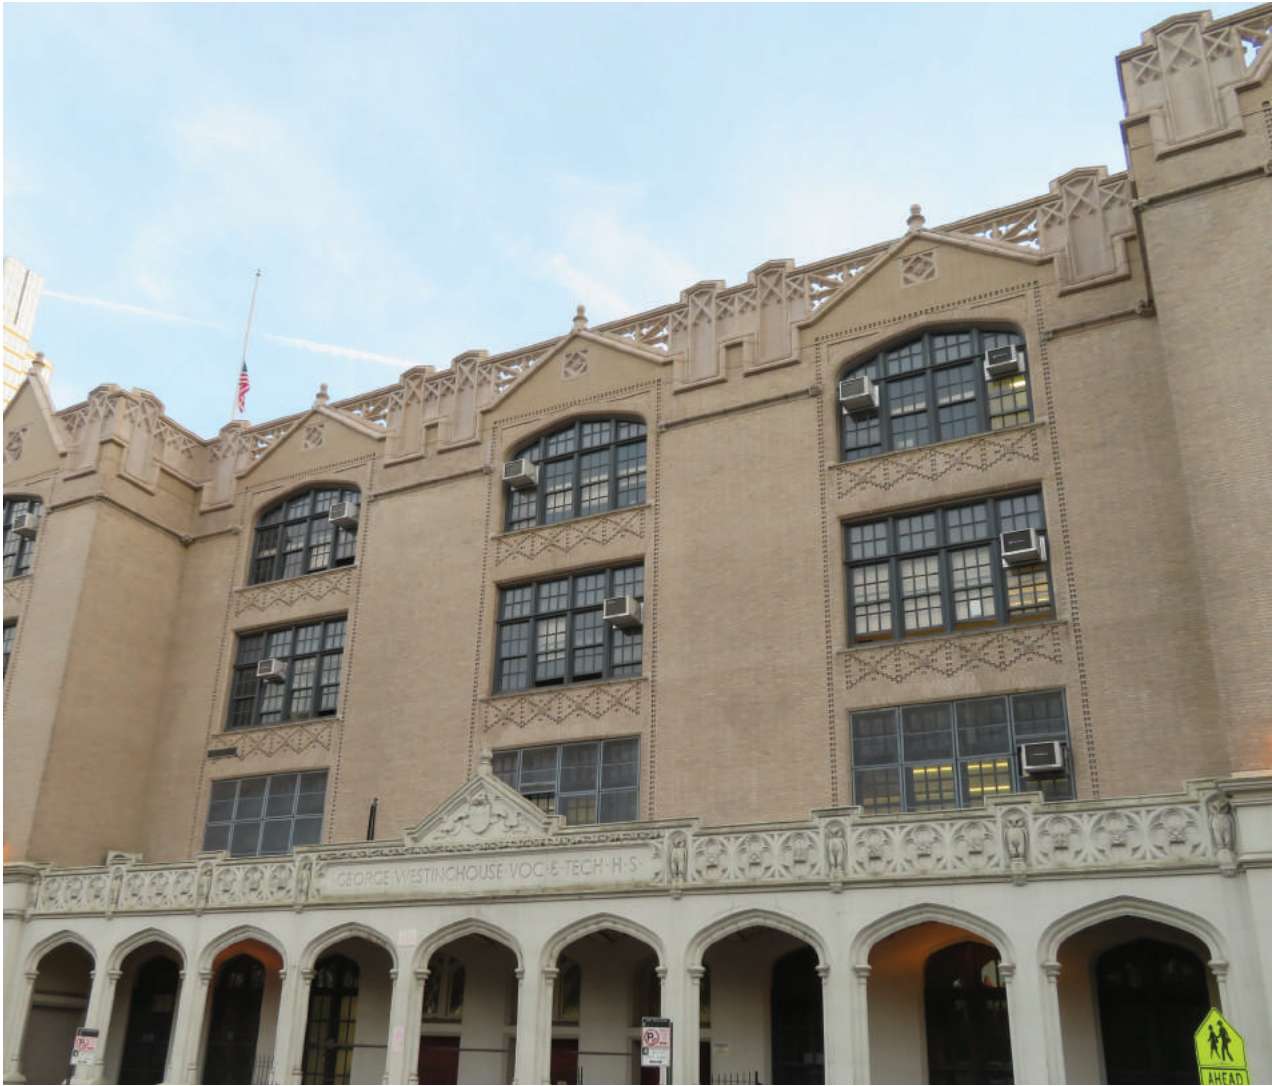
George Westinghouse Career and Technical Education High School, Tillary Street facade -- All photos by SUPERSTRUCTURES

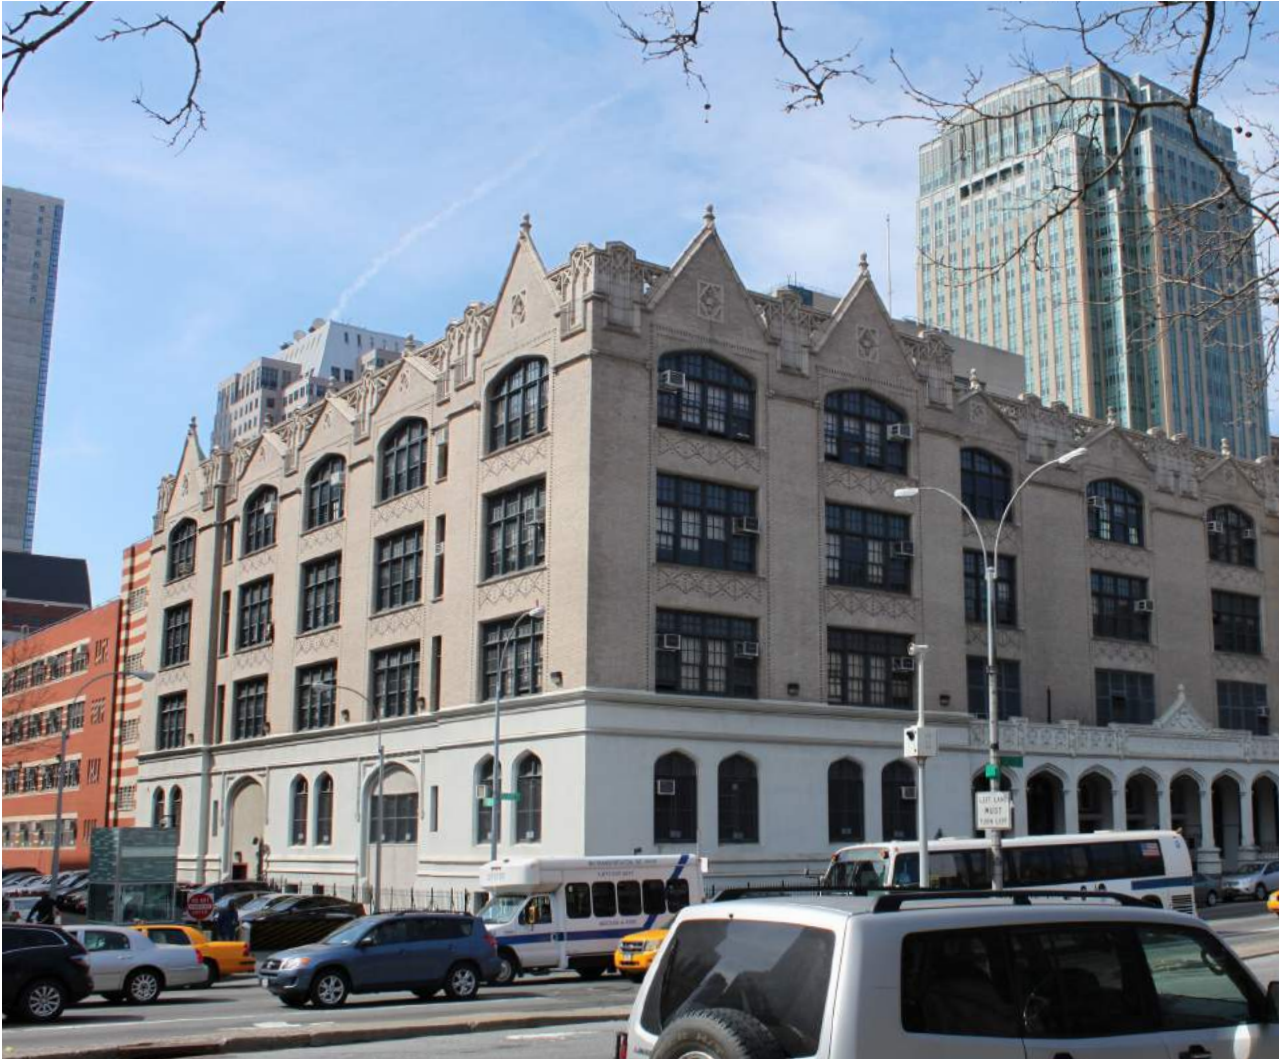
*George Westinghouse High School, 1960s addition at left along Bridge Street facade*

The additional building, completed in 1963, was designed by Keally and Patterson Architects and is in stark contrast with the original building due to its red brick facades and horizontal relief consisting of buff bricks above and between the street facing windows. The additional building's parapets are brick masonry with cast stone copings and railings to achieve the required height of 42”.

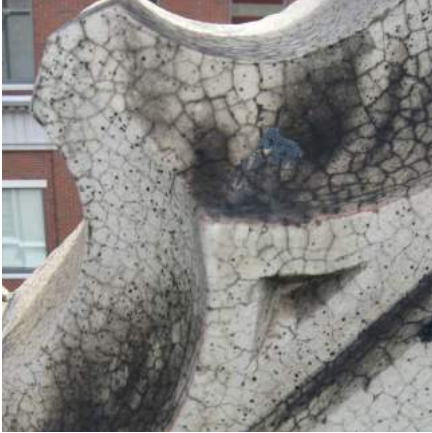
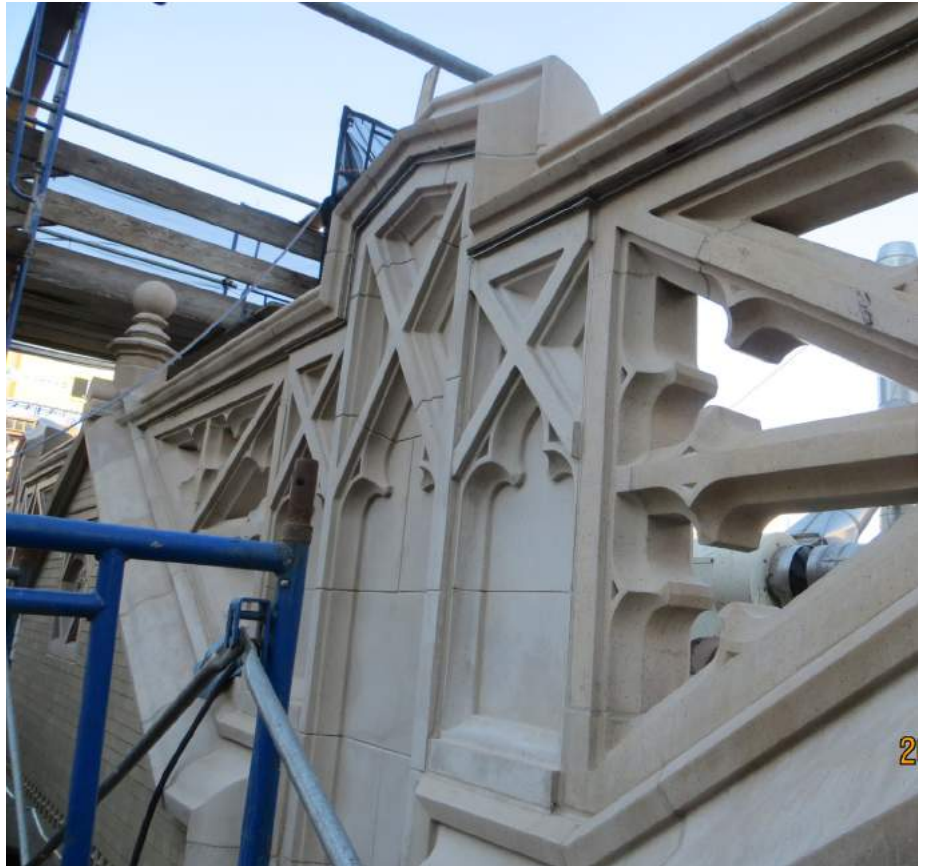
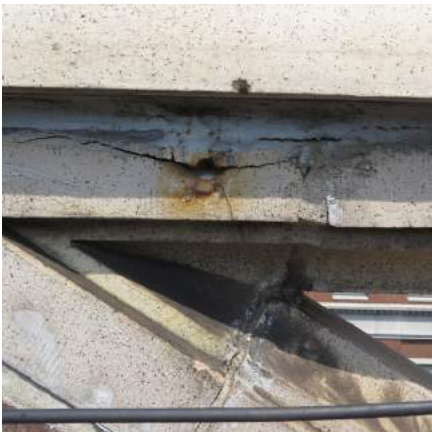
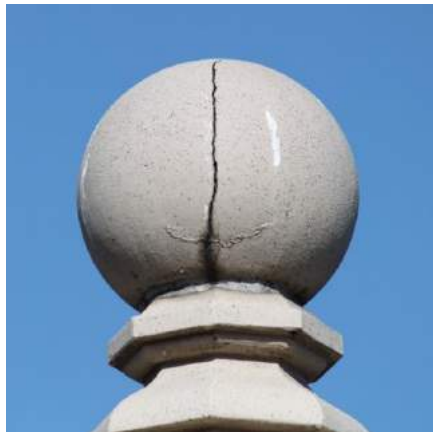
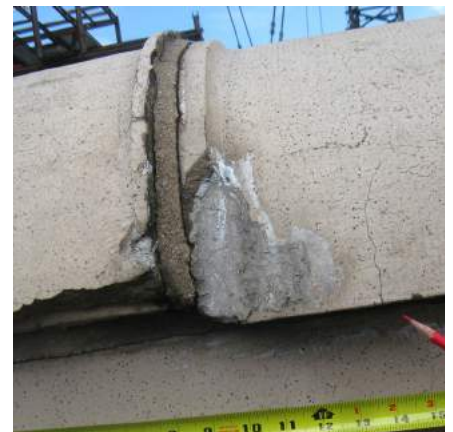
## Parapets

*Top left, bottom left, center and right: Parapet components before restoration. Top right: portion of restored parapet.*

The entire street facing parapet was replaced in kind, to address extensive masonry deterioration - cracked, spalled and displaced terra cotta and bulging brick masonry as a result of corroding steel within the masonry walls. The off-street parapet was also replaced to address the deteriorated brick masonry, which was the cause of water infiltration into the interior of the building. Existing elements were carefully documented. All replacement masonry was selected to match existing materials in shape, color and texture. Architectural pre-cast concrete and glass-fiber-reinforced concrete were used in reconstructing the ornate parapet. SUPERSTRUCTURES wrote its specifications so that those two products would perform harmoniously and

were made by the same manufacturer to ensure their visual compatibility. This work included removal of brick masonry and terra cotta at parapet level, down to the 4th-floor window lintel level arch. Careful parapet design and detailing was required to accommodate support for masonry, flashing and moisture control, and allow for expansion and contraction, while exactly replicating masonry in scale, color, shape and detail. Exposed structural steel elements were cleaned and coated and reinforced where deterioration had occurred. New vertical expansion joints and through-wall flashings were installed. Interior finishes damaged by water infiltration were repaired. SUPERSTRUCTURES worked closely with manufacturers, MIA and the contractor to ensure project success.

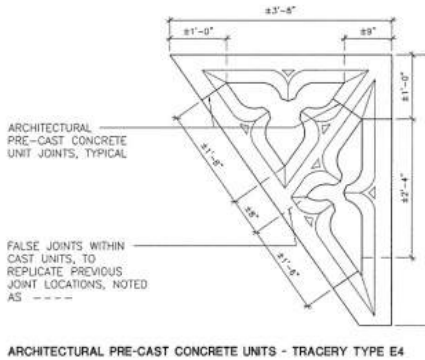
Above: Detail drawing of pre-cast concrete unit for parapet. Top left, and bottom left, center and right: during demolition and construction of parapet. Top right: Portion of restored parapet and coping.

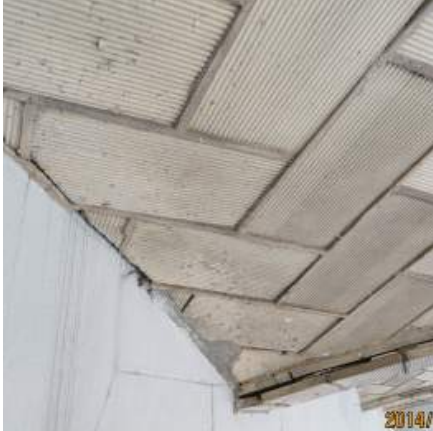
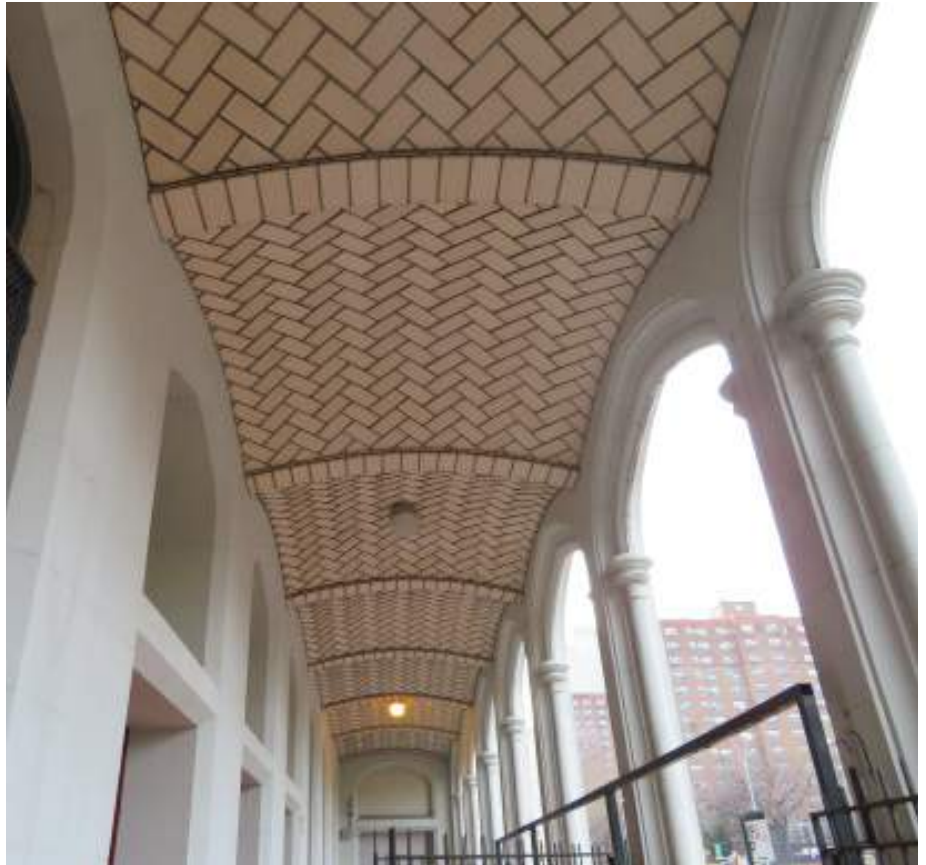
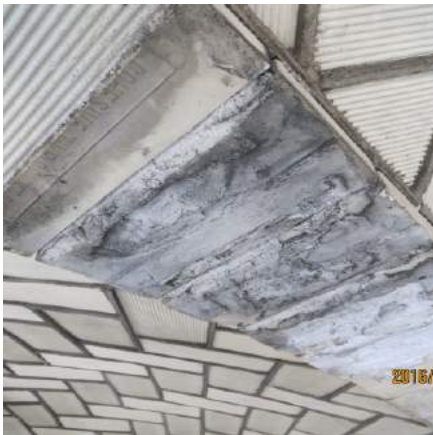
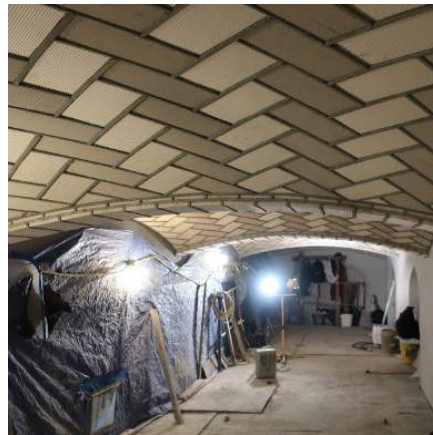
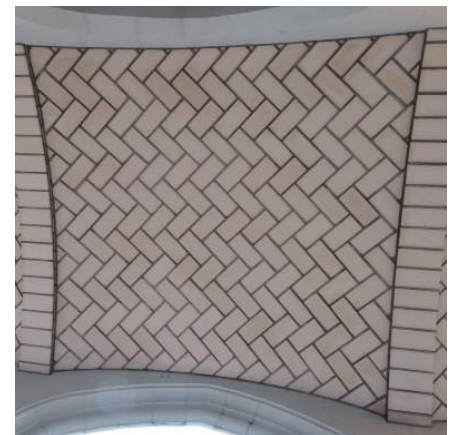
## Guastavino-Tiled Ceiling

*Top left: tiled ceiling before restoration. Bottom left and center: ceiling during construction. Top right and bottom right: restored Guastavino tile ceiling.*

The arched Guastavino-tiled ceiling in the Tillary Street loggia, which had been damaged by water infiltration from above was fully restored. The entire first layer of tile was replaced. SUPERSTRUCTURES prepared custom specification for the work. The contractor hired a speciality subcontractor to carry out this portion of the restoration. The roof above the tiled ceiling was also replaced to prevent further water infiltration.

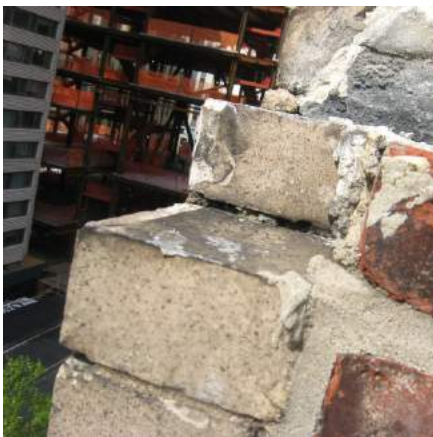
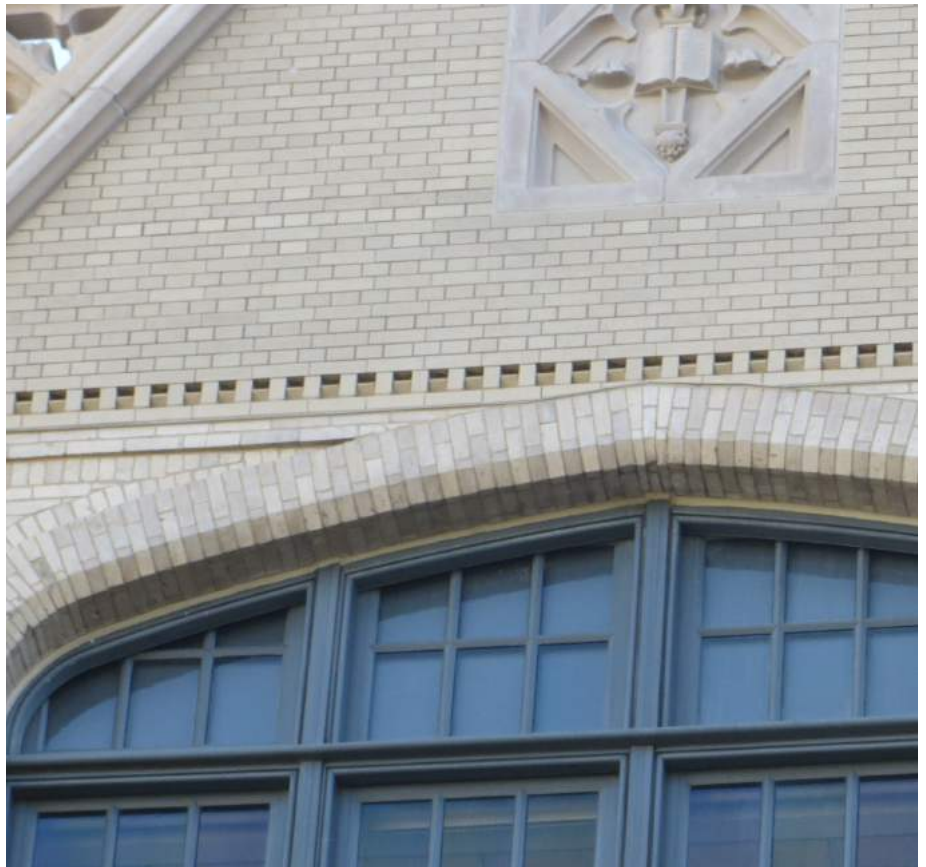
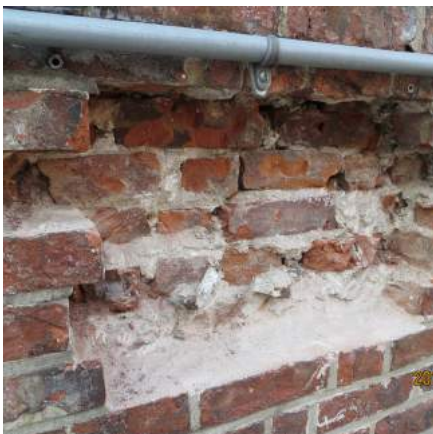
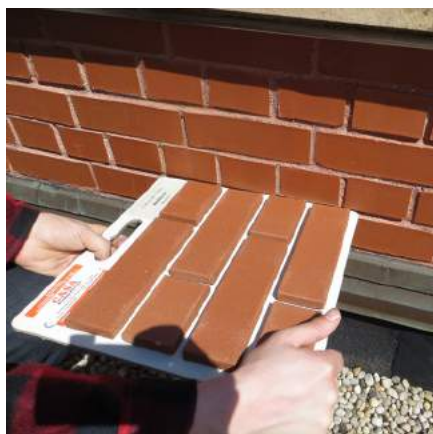
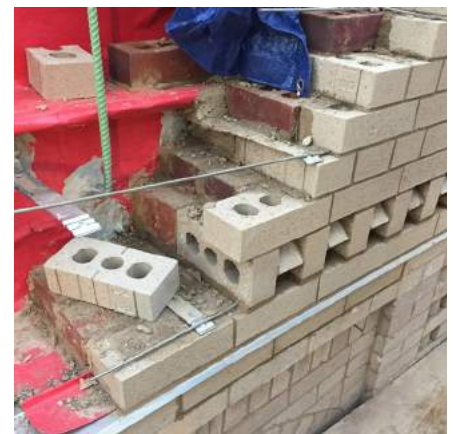
## Exterior Masonry

*Top and bottom left: masonry prior to restoration. Bottom center and right: masonry restoration in progress. Top right: section of restored masonry.*

The repair of exterior masonry included the following:

- Miscellaneous cracked/deteriorated face brick replacement. New brick and mortar matched existing in shape, color and texture,
- Machine tool cleaning, priming and painting of various lintels at various facade locations,
- Corner reconstruction of cracked brick masonry at addition building,
- Miscellaneous sealant replacement, where deteriorated, and
- Concrete patching at areaway curbs.

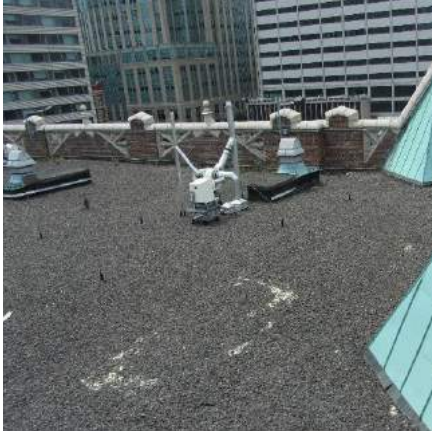
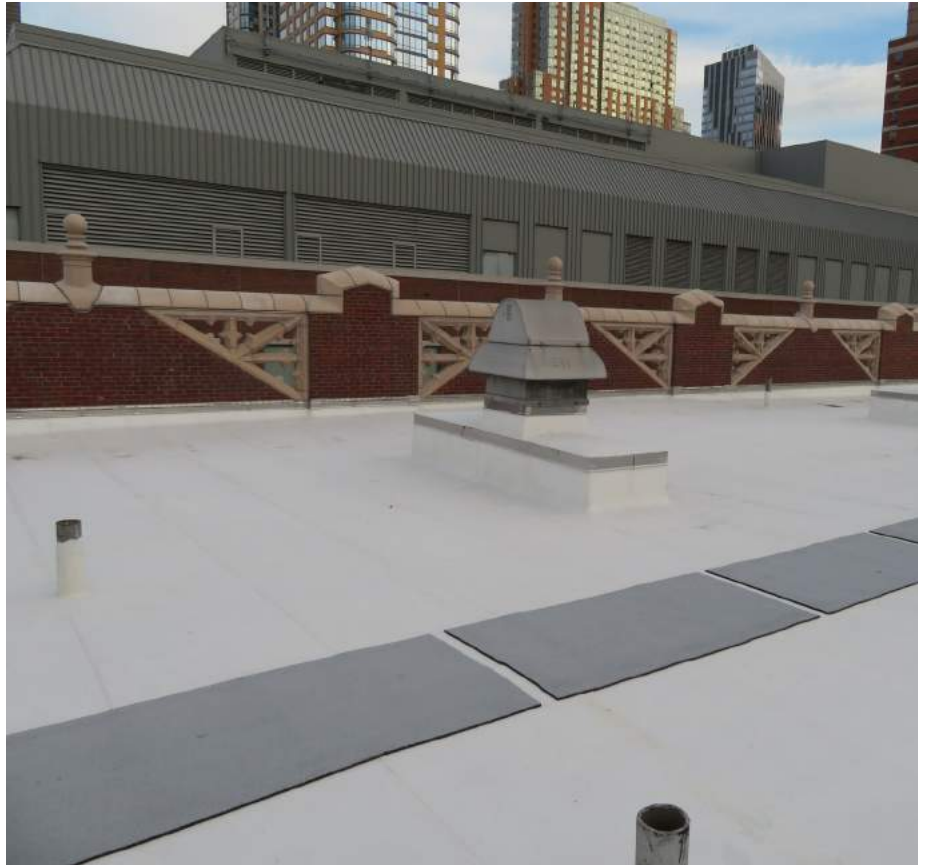
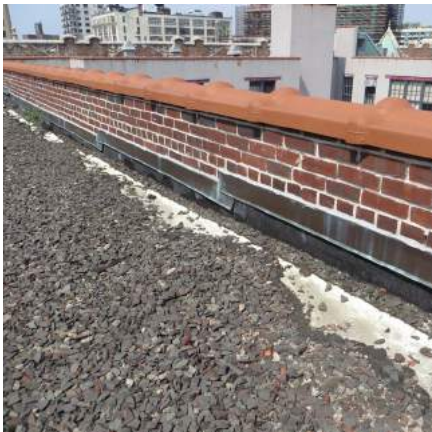
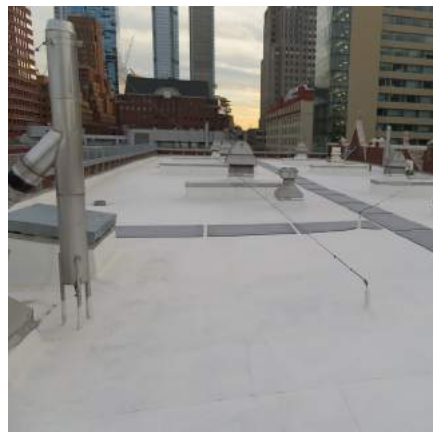
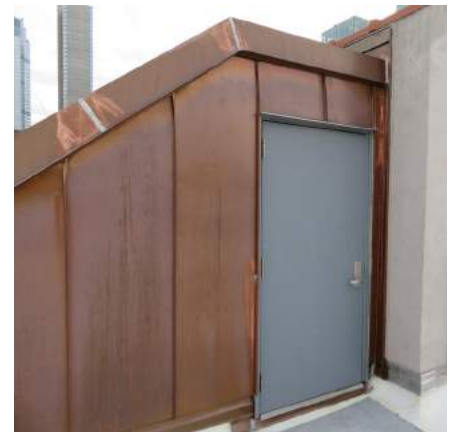
## Roofs

*Top left, bottom left: Roof prior to replacement. Top right and bottom center: roof after replacement. Bottom right: restored bulkhead.*

Existing flat, IRMA roofs and pitched standing seam copper roofs throughout the original building were replaced. The work included:

- Removal of existing deteriorated/leaking roofing systems,
- Installation of new steel bracing and new built-up roof systems,
- Replacement of roof drains,
- New copper standing-seam cladding and flat-seam roof at bulkhead.
