FIELD REPORT

Project:	Fire Island Lighthouse Testing Prog.	Report #:	2
Inspection Date:	June 10-June 14, 2019	Conditions:	64°F-75°F, Variable
Contractor:	Apple Restoration (Apple)		
Prepared by:	Corey Manchenton	Reviewed By:	Nancy Rankin

SUMMARY – WEEK 2

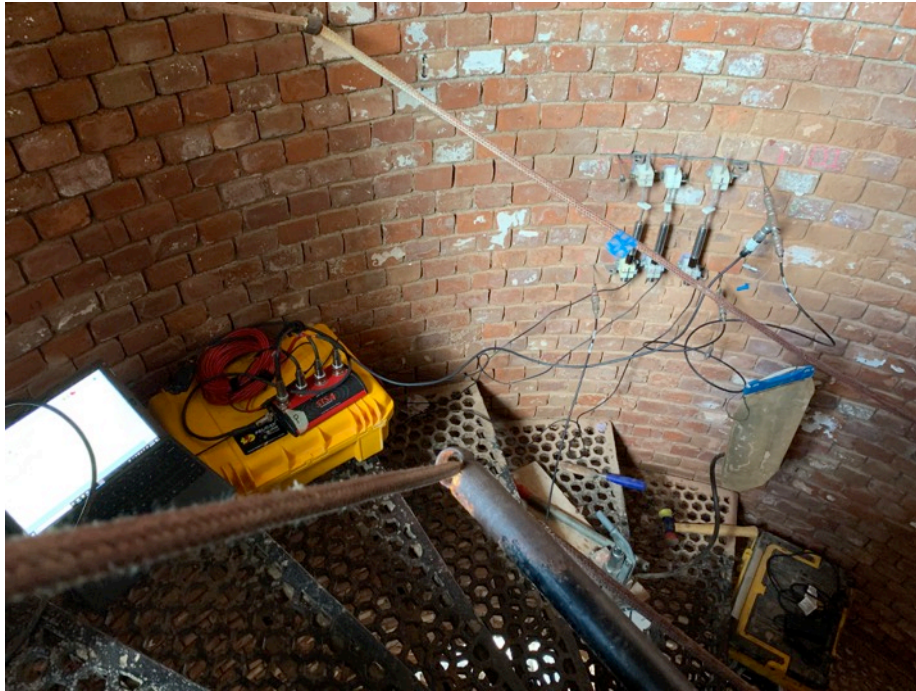
Photograph #22

Lighthouse Interior,
Above 4th Floor
Window

Temporary
Installation of all
equipment for flat
jack testing.

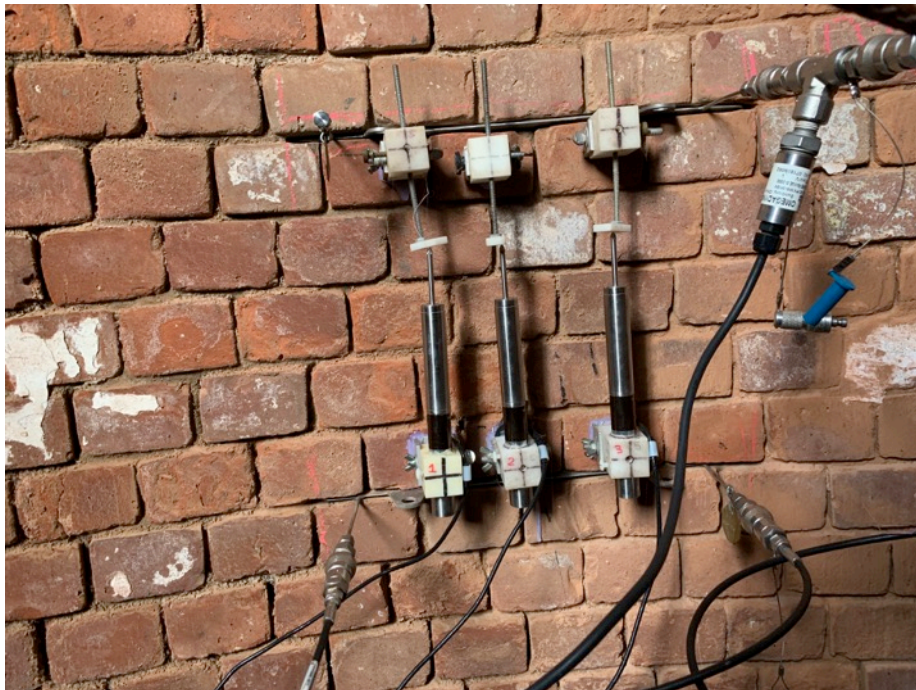
Photograph #23

Lighthouse Interior,
Above 5th Floor
Window

Temporary
Installation of all
equipment for flat
jack testing.

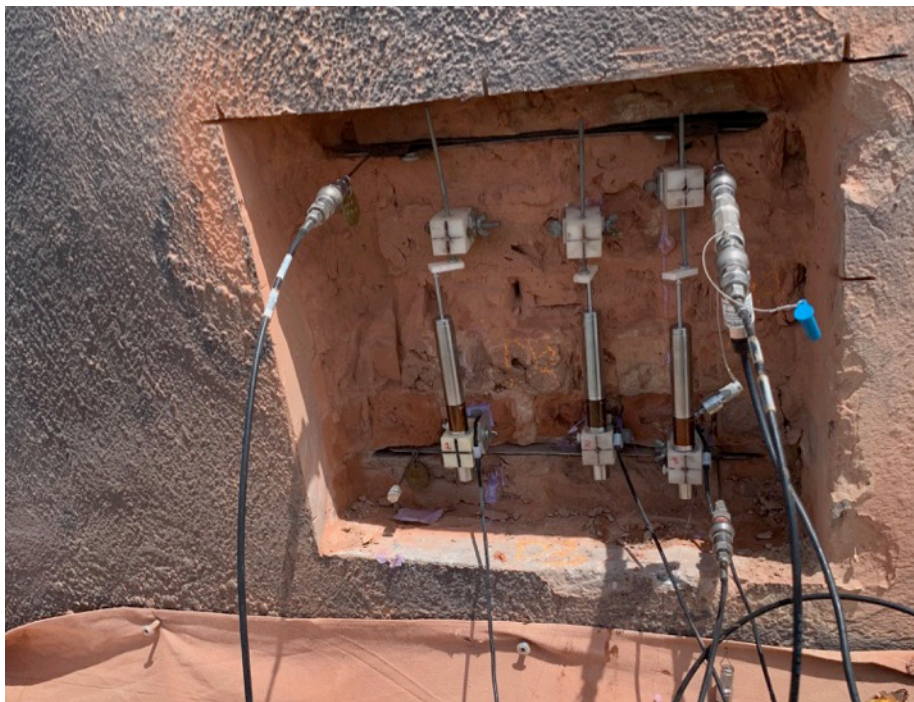
Photograph #27

Lighthouse, West Elevation, ground level

Temporary Installation of all equipment for flat jack testing.

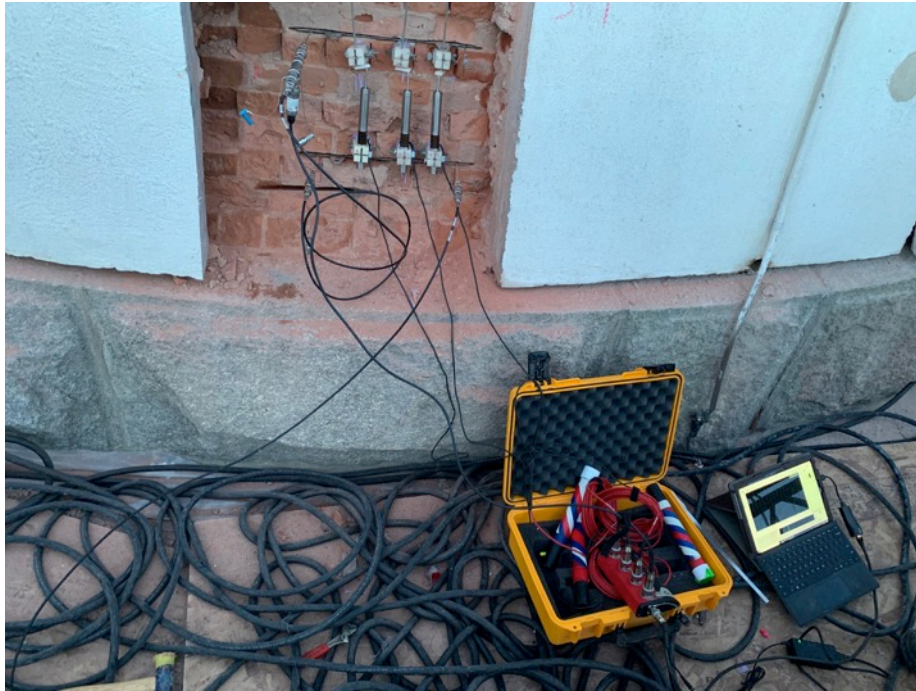
Photograph #28

Lighthouse, West Elevation, adjacent to the 5th floor landing's window.

Temporary Installation of all equipment for flat jack testing.

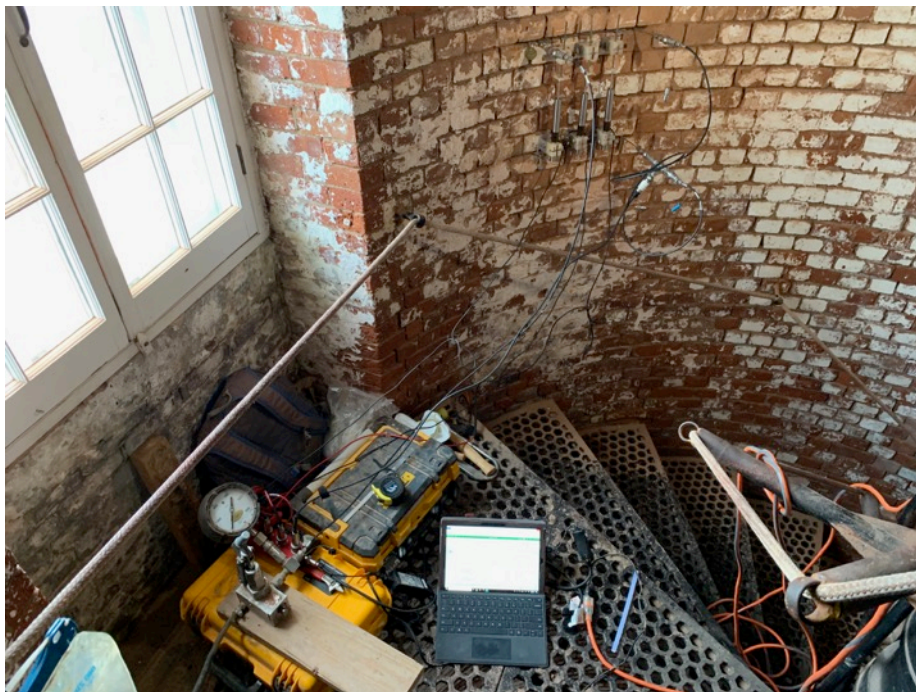
Photograph #29

Lighthouse, West
Elevation, ground
level

Temporary
Installation of all
equipment for stress
testing.

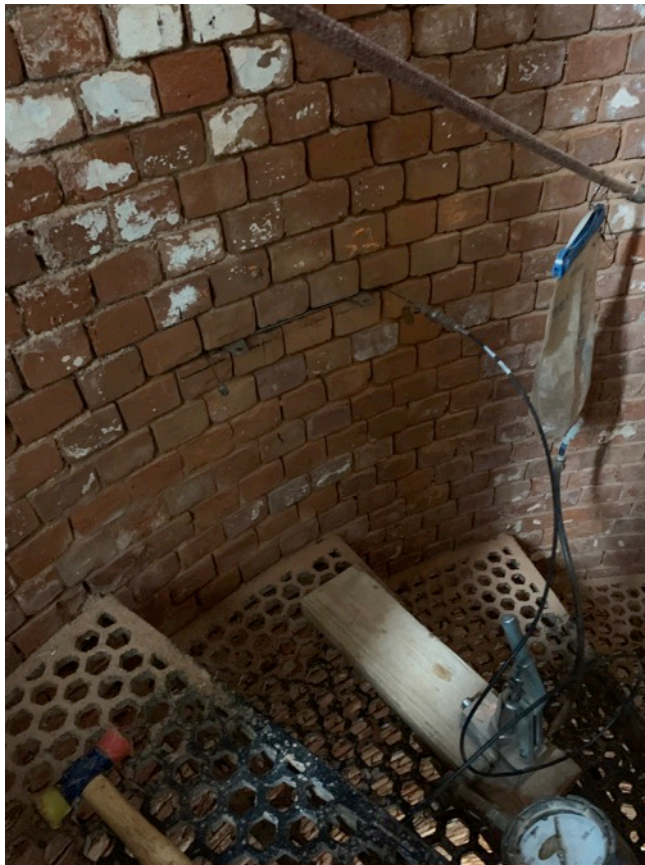
Photograph #31

Lighthouse Interior,
Above 4th Floor
Window

Area for flat jack
testing prior to cutting
of joints/testing.

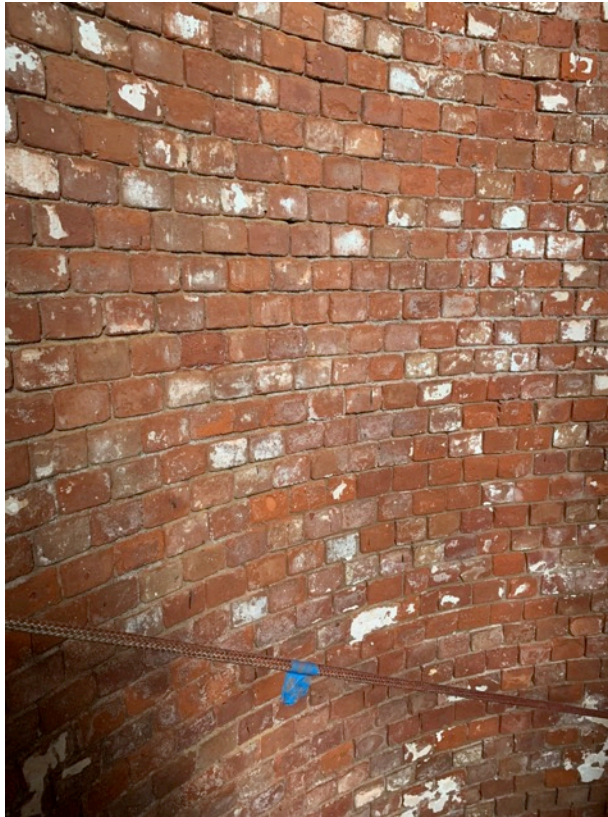
Photograph #32

Lighthouse Interior,
Above 4th Floor
Window

Removal of mortar
from joints using the
Arbortech machine.

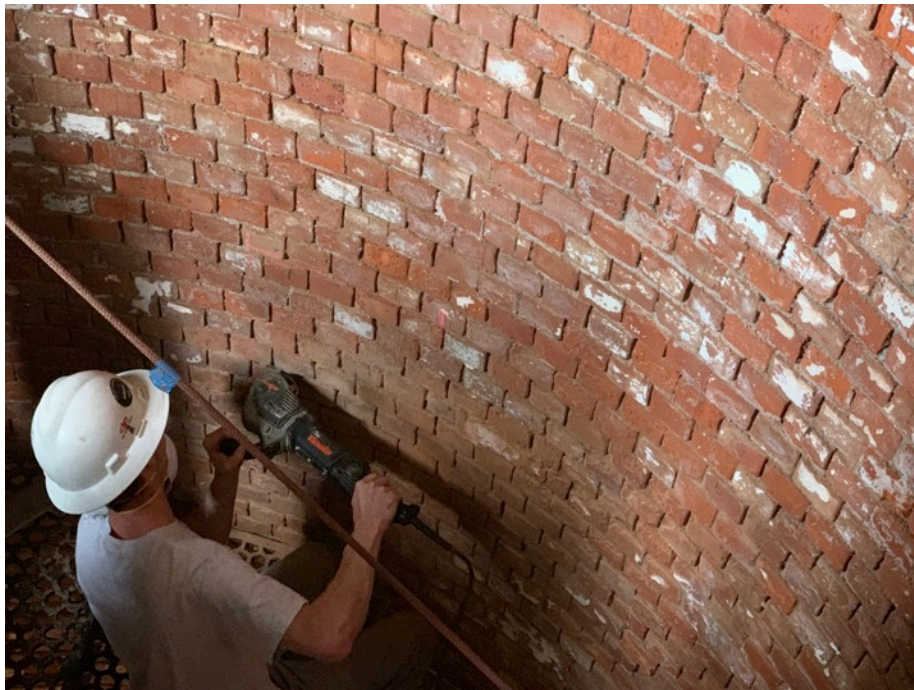
Photograph #33

Lighthouse Interior,
Above 4th Floor
Window

Installation of metal
bladders in joints five
(5) joints apart.

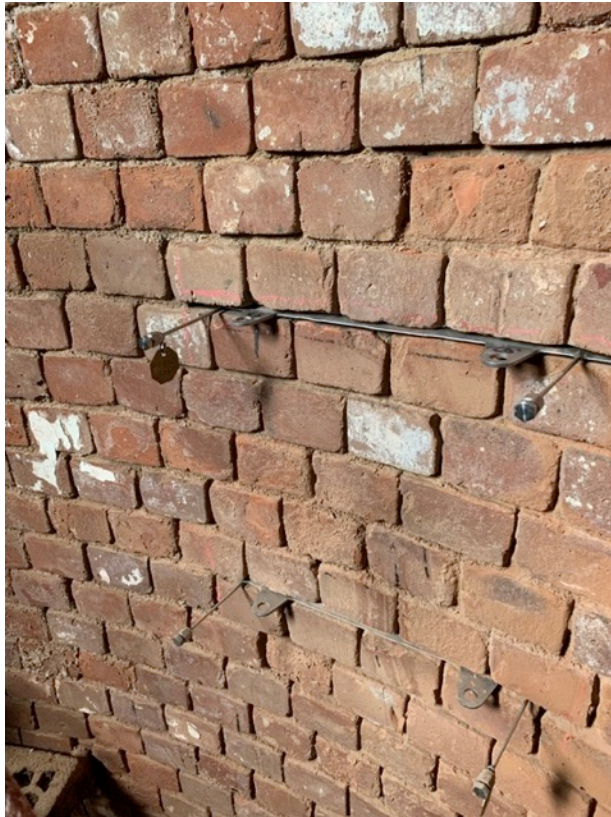
Photograph #34

Lighthouse Interior,
Above 4th Floor
Window

Temporary
attachment of testing
equipment to interior
of lighthouse masonry
wall utilizing hot glue.

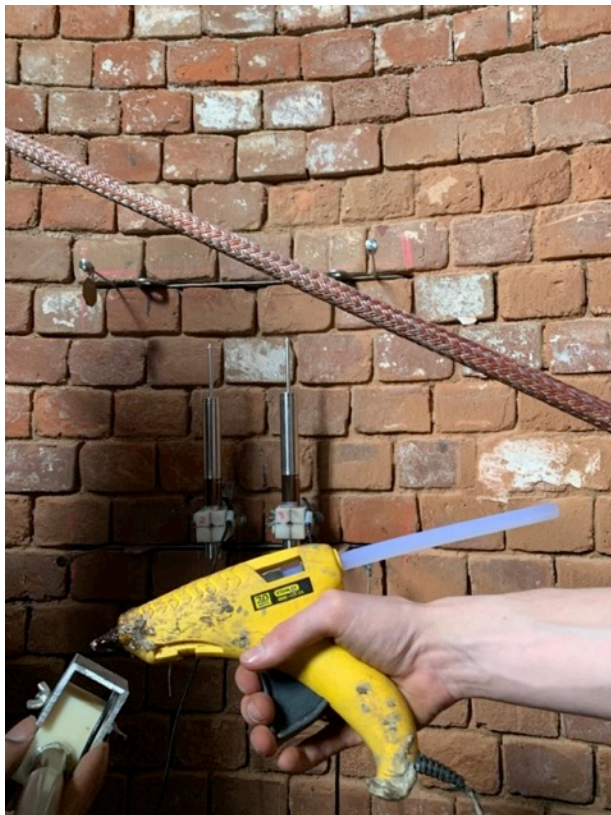
Photograph #35

Lighthouse Interior,
Above 4th Floor
Window

Temporary
Installation of all
equipment for flat
jack testing.
